Noise Localization via Acoustic Emission Monitoring on a Rolling Leaf Bascule Bridge

Tested September 18–19, 2008

Infrastructure Technology Institute
Northwestern University

Final Report — June 10, 2009

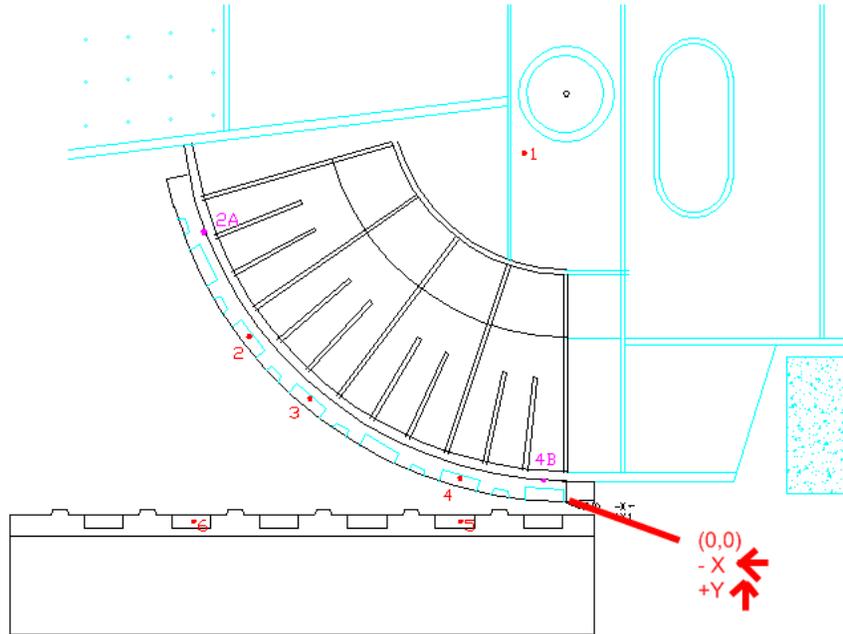
Figure 1: Overview of bascule girder/track area showing primary (Array A) sensor locations and the coordinate system used in analysis. Note that for planar location along the bascule girder, the coordinate system rotates and translates with the movement of the bridge; i.e., the coordinate system is defined by sensors 2, 3, and 4. Locations 2A and 4B were used exclusively for the displacement measurements described in Analysis #5.

We used a coordinate system with the origin at the point of contact between the bascule girder and bottom forging when the leaf is fully closed. For consistency with the standard Cartesian system, the bascule girder translates in the negative direction along the x -axis as the leaf opens. Figure 1 shows an overview of the bascule girder/track area with the primary (Array A) sensor locations and coordinate system.

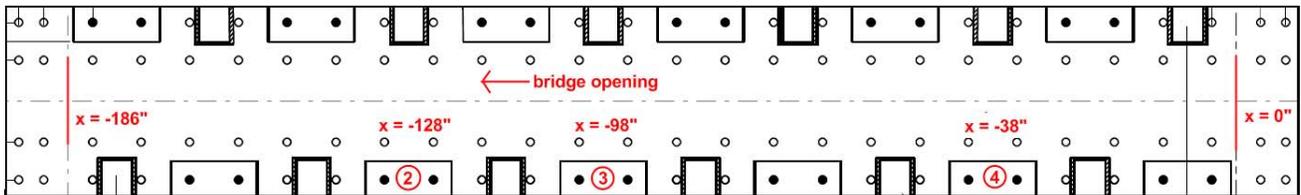
Figure 2: Reflected view of AE transducer locations and one-dimensional coordinate system used in “un-rolled” linear location analysis along the curved upper forging bolted to the bascule girder. Dimensions represent distances along the arc of the forging, not chord distances. Overview of bascule girder/track area showing primary (Array A) sensor locations and the coordinate system used in analysis. Note that for planar location along the bascule girder, the coordinate system rotates and translates with the movement of the bridge; i.e., the coordinate system is defined by sensors 2, 3, and 4.

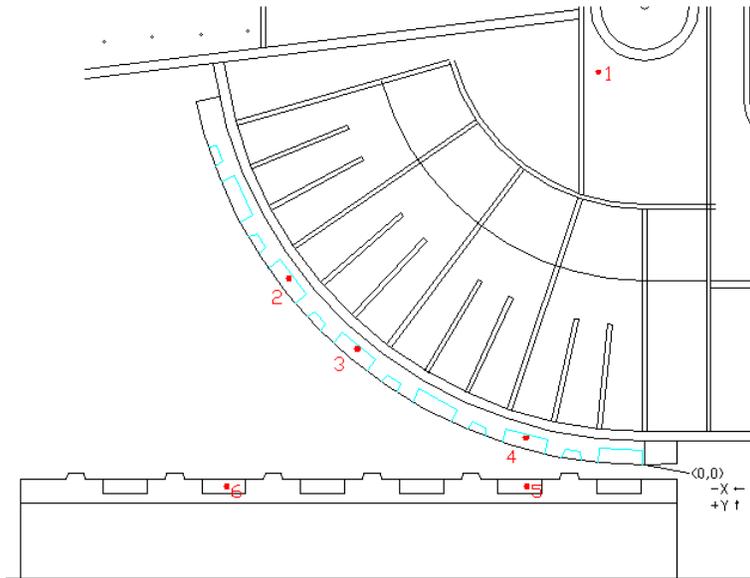
Figure 3: AE array “A” was deployed similarly on the west leaf, south bascule girder and east leaf, north bascule girder. This array was used for first-hit channel analysis.

Our primary sensor layout for FHA was Array “A,” shown in Figure 3. This is the configuration included in our initial testing proposal. One AE sensor was placed on the bascule girder near the pinion gear, three on the curved upper forged track, and two on the lower straight forged track. This testing was performed on one bascule girder on each leaf. We compared the average number of first hits per lift cycle on the west-south bascule girder, which exhibits the audible bangs, to the east-north bascule girder, which is quiet and serves as a baseline for normal operation. Figures 4 and 5 clearly show that the source of the bangs is a region including the curved outer periphery of the bascule girder and the curved forging.

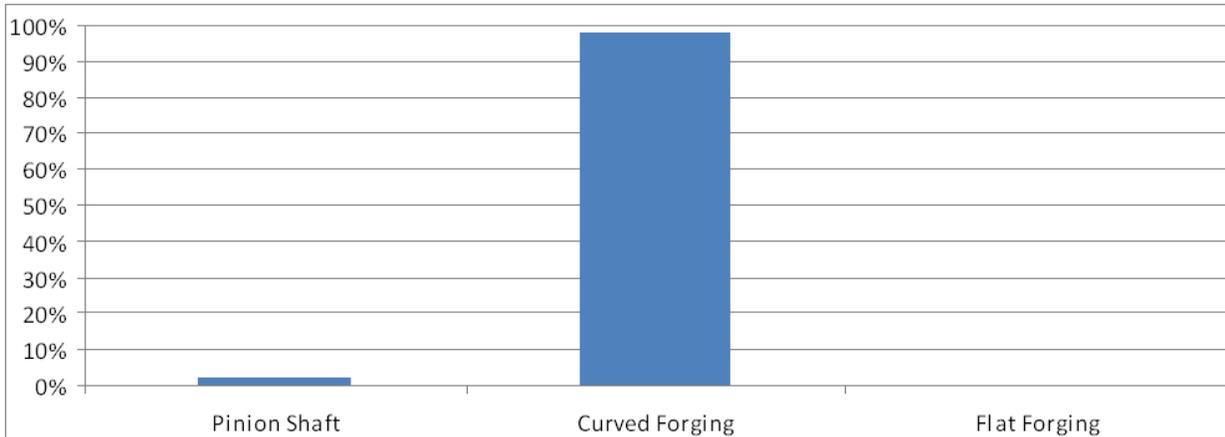
Figure 4: Results of first-hit analysis on the west leaf, south bascule girder. 98% of high-energy AE events hit Channels 2, 3, or 4 first, indicating that they originated near the curved forging-bascule girder interface. The balance originate near the pinion shaft; no high-energy AE events originate from the flat forging.

Channel	Total hits (percentage of total hits) on west-south bascule during Runs 1–5	Average hits per cycle during Runs 1–5	Total hits on east-north bascule (Runs 9–10)
1	4 (2.0%)	1	0
2	53 (26.8%)	11	0
3	58 (29.3%)	12	0
4	83 (41.9%)	17	0
5	0 (0.0%)	0	0
6	0 (0.0%)	0	0

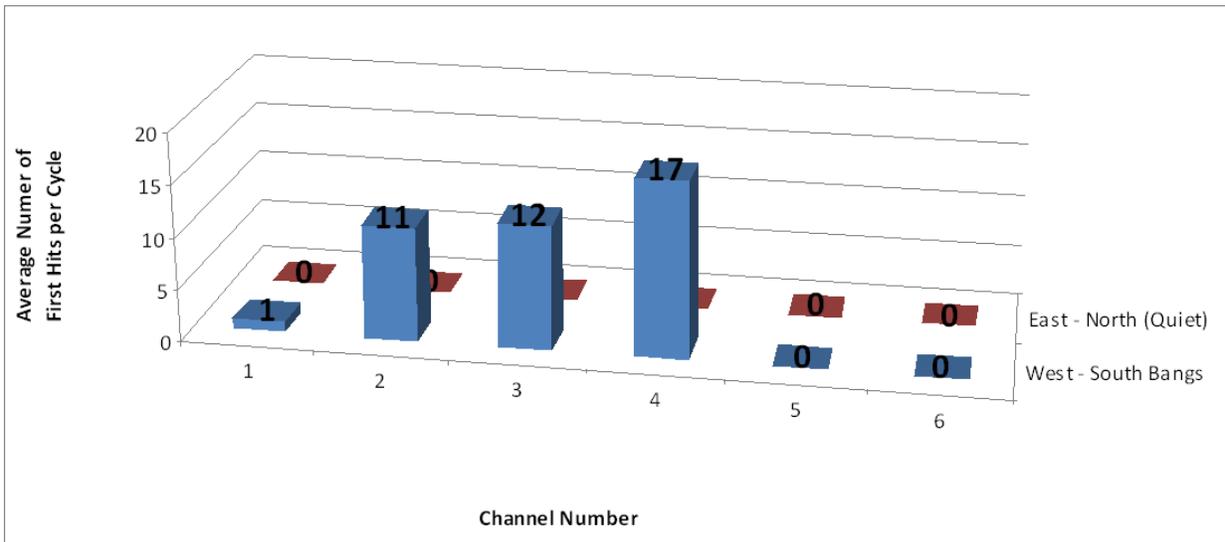
Figure 5: Comparison of first-hit results from high-energy AE events on the noisy west-south bascule girder and the quiet east-north bascule girder. Nearly all the high-energy AE events on the noisy bascule girder hit Channel 2, 3, or 4 first, indicating the events originated near the curved forging-bascule girder interface. No high-energy AE events were recorded on the quiet bascule girder.

Finally, the number of high-energy AE events for the west and east leaves followed the same pattern as audible bangs heard by human observers: the east leaf is much “quieter” than the west leaf, yielding neither audible bangs nor high-energy AE events.

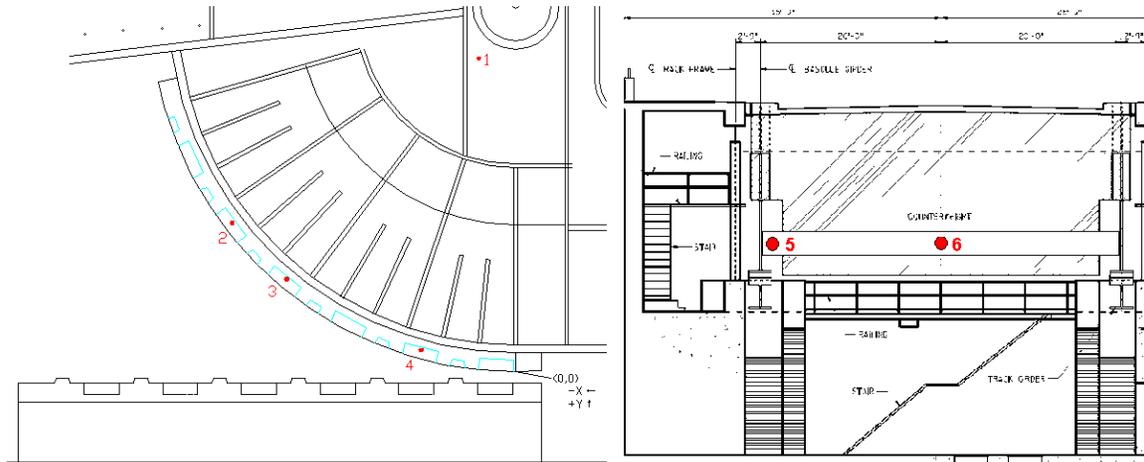
Figure 6: AE array “B” was deployed on the west leaf, with AE Sensors 1–4 on the south bascule girder and Sensors 5 and 6 on the transverse machinery strut. This array was used for comparison of AE activity from the north vs. south bascule girders.

In this analysis we attempted to determine if the audible bangs were produced at one or both bascule girders on the west side of the bridge. Additionally, we sought to quantify the ratio of bangs produced on the south bascule girder versus those produced on the north bascule girder. The sensor layout shown in Figure 6 was applied to the south bascule girder on the west leaf. Sensors 5 & 6 were placed on the machinery strut, a large transverse beam between the bascule girders. Sensor 5 was at the south end of the floor beam, just behind the bascule girder and Sensor 6 was at the midpoint of the floor beam.

It was hoped that the acoustic signals of the audible bangs would be of high enough amplitude that they would be consistently measurable at the midpoint of the floor beam, 20 feet from each bascule girder. By looking at the first-hit counts at Sensors 5 and 6, we could then quantify the relative acoustic activity originating from each bascule girder. However, when the energy filter corresponding to our best understanding of the AE characteristics of the audible bangs was applied, the results were inconclusive. This may be attributed to attenuation of the acoustic signals along the 20 foot path between Sensors 5 and 6 or the existence of other AE sources or other propagation paths along the structure. A more definitive test would have been to have AE sensors on both bascule girders, but we did not have sufficient length cabling at the time of testing.

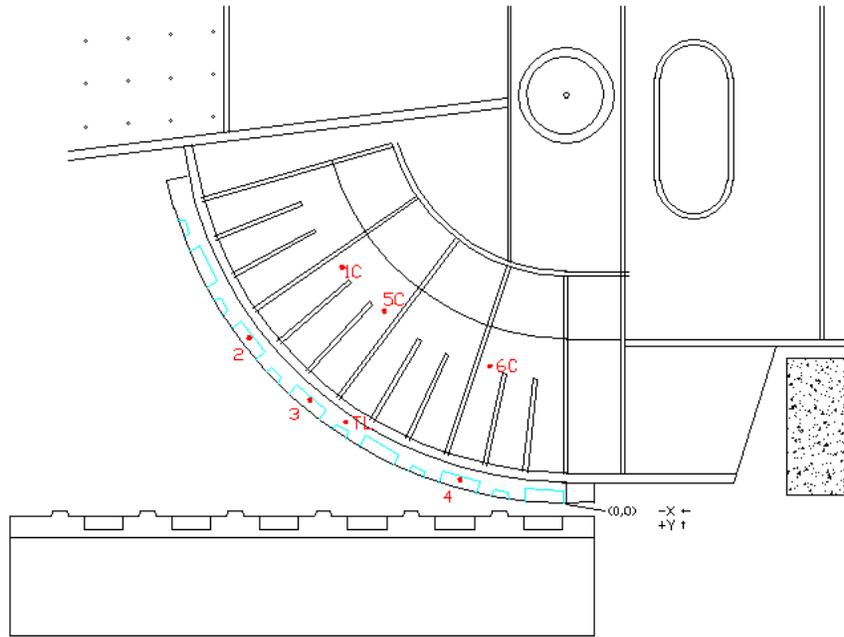
Figure 7: AE array “C” was deployed on the west leaf, south bascule girder for linear location analysis by “unrolling” the curved upper forging on the bascule girder. The three sensors closest to the pinion were used as guard sensors to intercept noise not coming from the curved forging.

Acoustic emission monitoring can be used to locate acoustic sources in one, two, or three dimensions by analysis of geometry, the speed of sound in the material, and the signal arrival times at each sensor. For this test we performed the simplest location analysis in one dimension by “unrolling” the curved upper forging on the bascule girder and treating it as if it was a straight rod. This is a valid assumption due to the geometry and our use of guard sensors to eliminate extraneous sources; the sensor layout is shown in Figure 7.

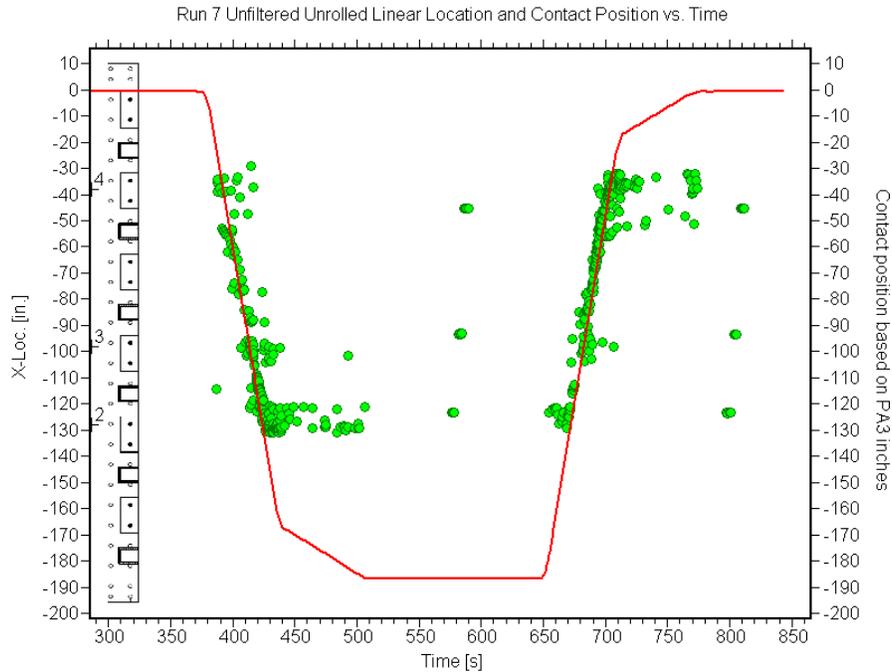
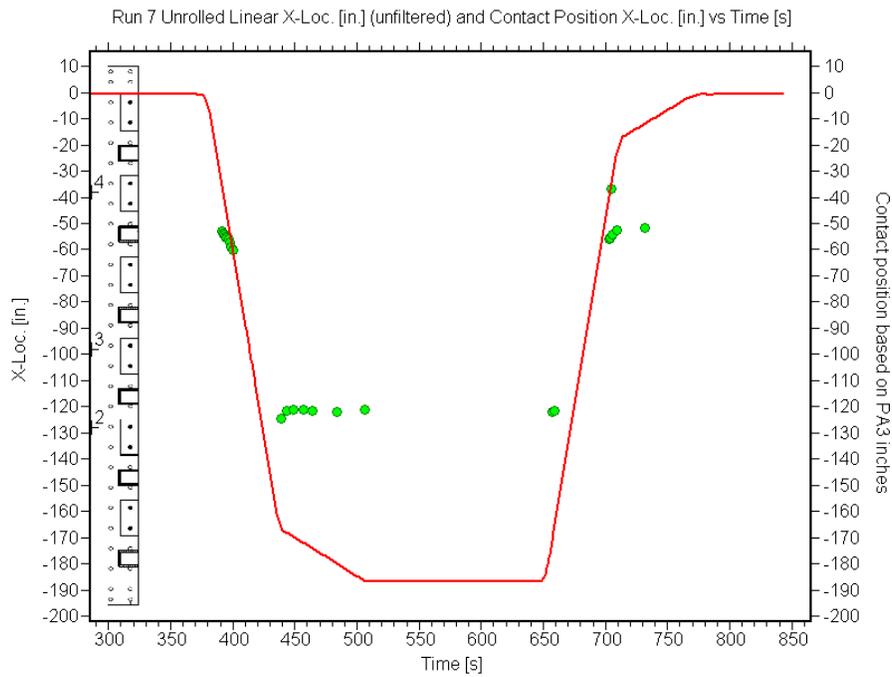
(a) Unfiltered

(b) Filtered, minimum energy of 600,000 AE energy units

Figure 8: Linear location along the upper forging during opening and closing of the west leaf in Run 7, unfiltered (a) and filtered (b).

Figure 8 shows the location of AE hits along the “unrolled” upper forging along with the position of the contact area as the bridge opens and closes.

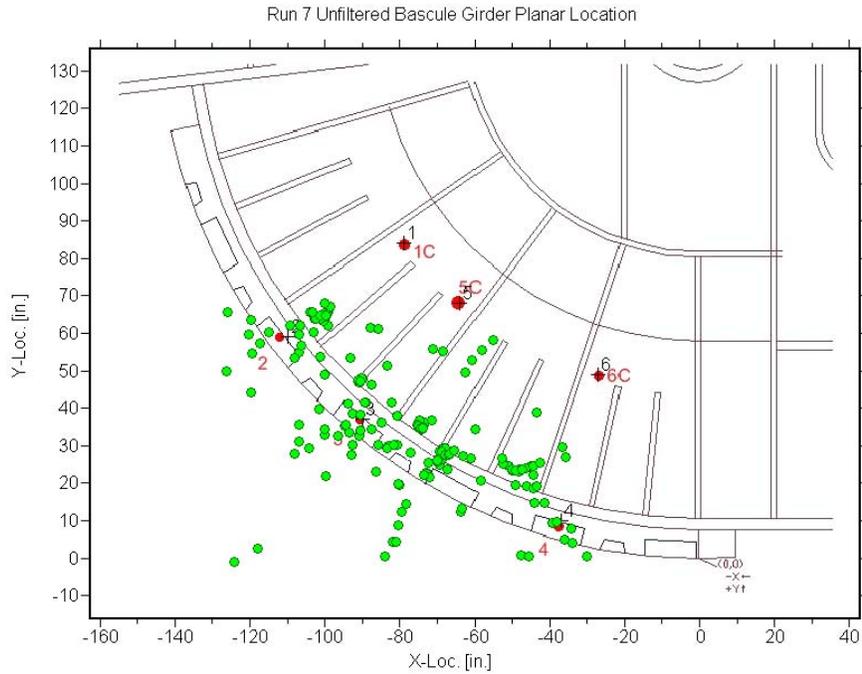
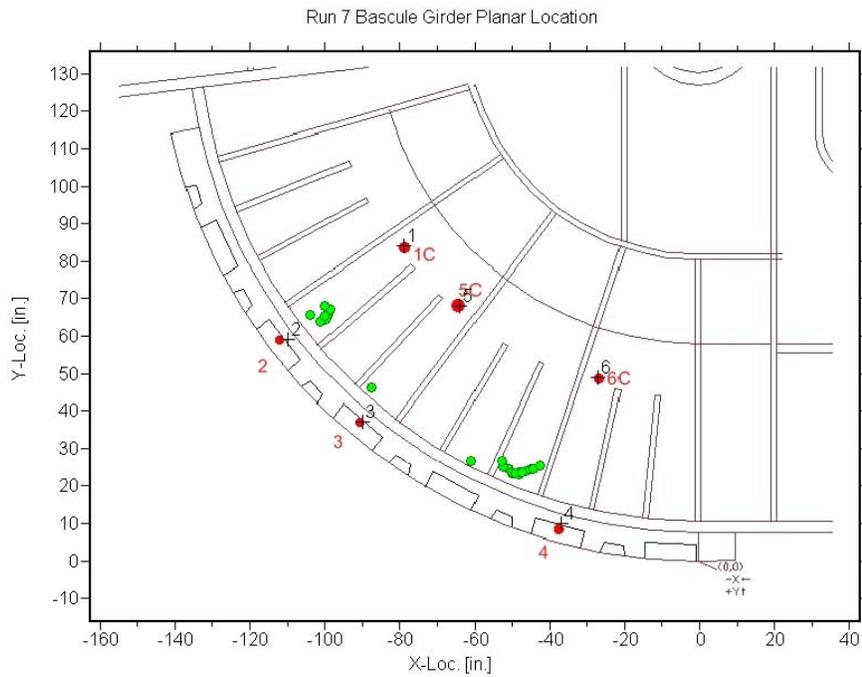
(a) Unfiltered

(b) Filtered, minimum energy of 600,000 AE energy units

Figure 9: Planar location along the upper forging during opening and closing of the west leaf in Run 7, unfiltered (a) and filtered (b).

Additionally, we performed planar location analysis on the data from Run 7. In this configuration, Channels 1, 5, and 6 were used in combined guard/normal mode; that is, AE events that reached those channels first were rejected outright, eliminating any noise from the pinion, while events that reached those channels after reaching Channels 2, 3, or 4 were located using the time-of-arrival data from all channels. The results, shown in Figure 9, indicate that the bulk of the locatable events originate along the arc of the bascule girder and curved forging. While the precision of the planar location results was reduced due to the complicated geometry of the bascule girder/curved forging interface, the location results seem to strongly support the hypothesis that the bangs originate somewhere along the bottom arc of the bascule girder.

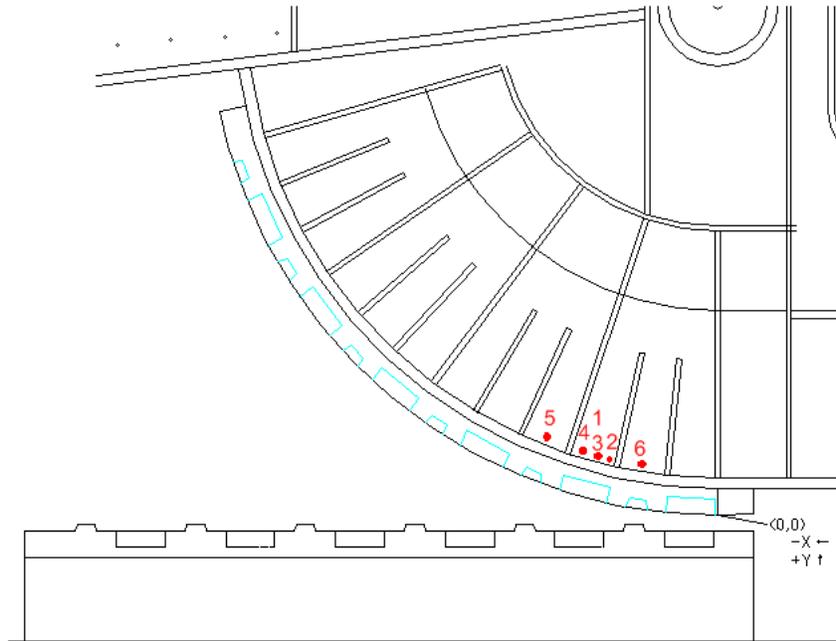
Figure 10: AE array “D” was deployed on the west leaf, south bascule girder for micro-localization of AE activity around the bolts connecting the curved upper forging to the bascule girder.

An AE test run was performed at the location shown in Figure 10 on the west-south bascule girder to determine if the bolts connecting the bascule girder to the curved forging were the source of the audible bangs. Transducers 1–4 were placed on the outside of the bascule girder between the bolts as shown in Figure 11.

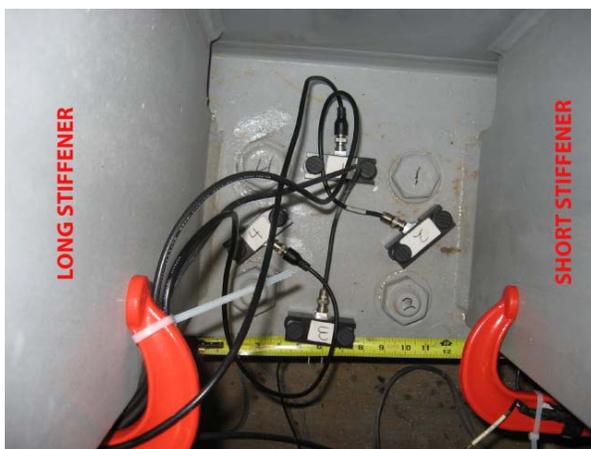
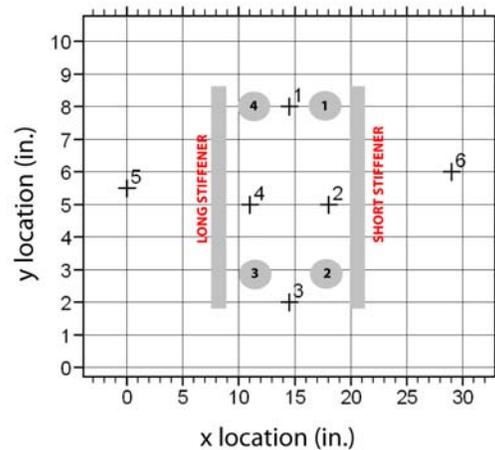
Figure 11: Photograph and drawing of array of AE transducers on bascule girder bolts near Location 4

AE Transducers 5 and 6 were placed approximately fifteen inches to the left and right of Transducers 4 and 2, respectively, on the opposite sides of the two radial stiffeners adjacent to the bolt grouping. Figure 11 shows the approximate relative positions of the AE transducers and radial stiffeners on the bascule girder. The right stiffener is the shorter of the two types of radial stiffeners on the bascule girder. The left stiffener is the full-length type.

Ultimately, no high-energy AE events (energy greater than 600,000 AE energy units) were recorded within the micro-location array. If the turned or tapped bolts were the source of the audible bangs, high-energy AE events would almost certainly have been detected near the bolts themselves. The complete absence of high-energy AE during Run 8 seems to rule out the bolts as the source of the audible bangs.

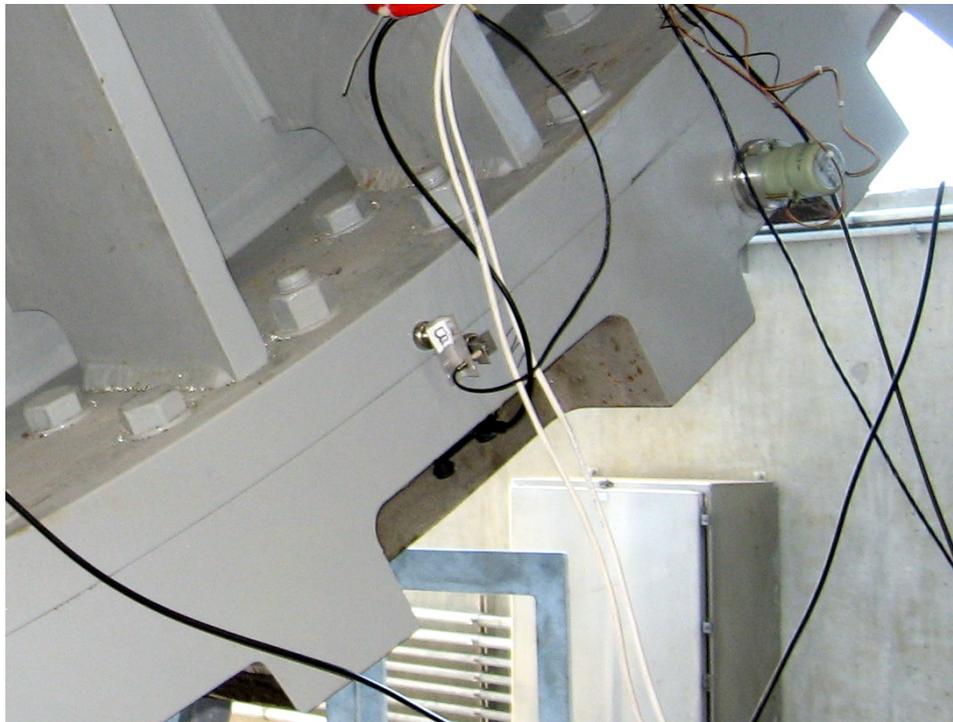
Figure 13: Eddy-current displacement sensor pair (metal bracket with inverted B on label) deployed across bascule girder-curved forging interface. The electronic clinometer (tiltmeter), a greyish cylinder magnetically mounted to the curved bottom forging, is also visible. All instrument cables were tied off to clamps on the bascule girder for strain relief.

As a supplement to AE measurements, we applied two displacement sensors across the gap between the bascule girder and the curved forging. This was done to monitor relative motion between the two members, which have been the source of acoustic events on other similar bridges that we have tested. The displacement sensors were applied to various locations along the gap with the temporary magnetic-mount fixture shown in Figures 12 and 13. These non-contact eddy current displacement sensors have resolution and frequency response well in excess of the recording capabilities of the auxiliary parametric inputs to the AE system to which they were attached, so any sensor-related error is insignificant.

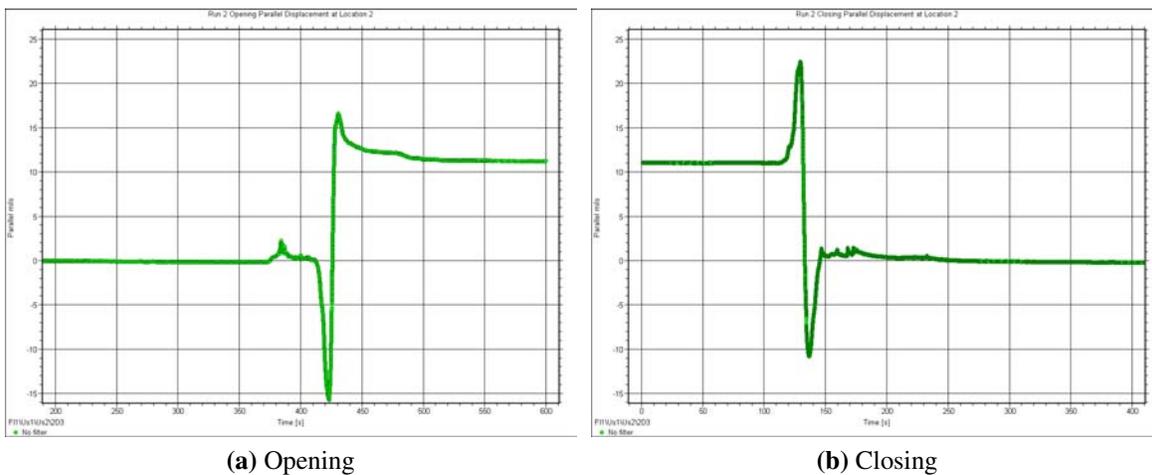
A typical open and close cycle is shown in Figures 14 and 15 with one sensor placed parallel across the gap and the other sensor placed perpendicularly across the gap at Location 2, approximately 132 in (along the arc of the bascule girder) from the resting contact point. Both plots are typical, repeatable, and return to zero, in the same manner as other measurements taken on the west end of bridge, south girder. The perpendicular displacements were under eight mils peak-to-peak, so only parallel placements were measured during the subsequent Runs 3–10.

Figure 14: Parallel displacement at Location 2, Run 1

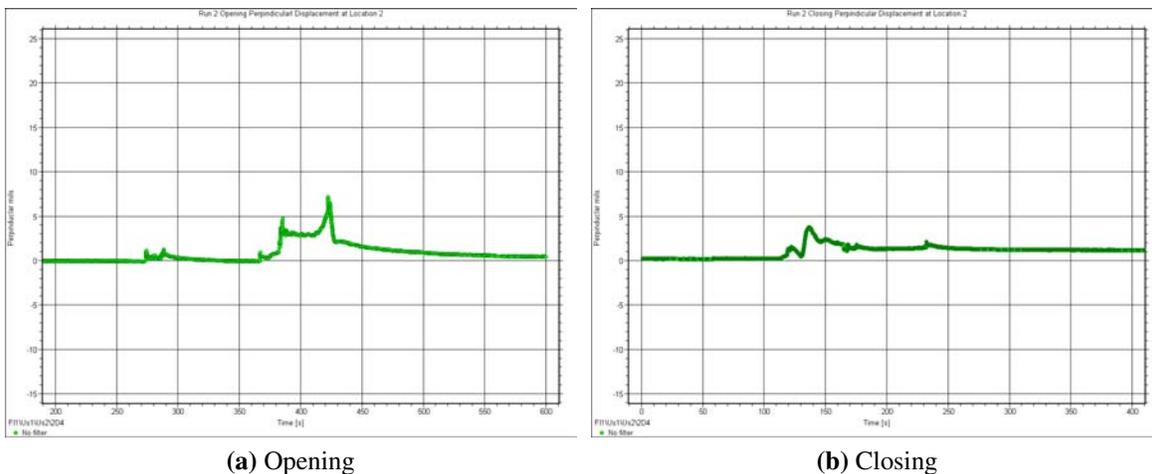
Figure 15: Perpendicular displacement at Location 2, Run 1

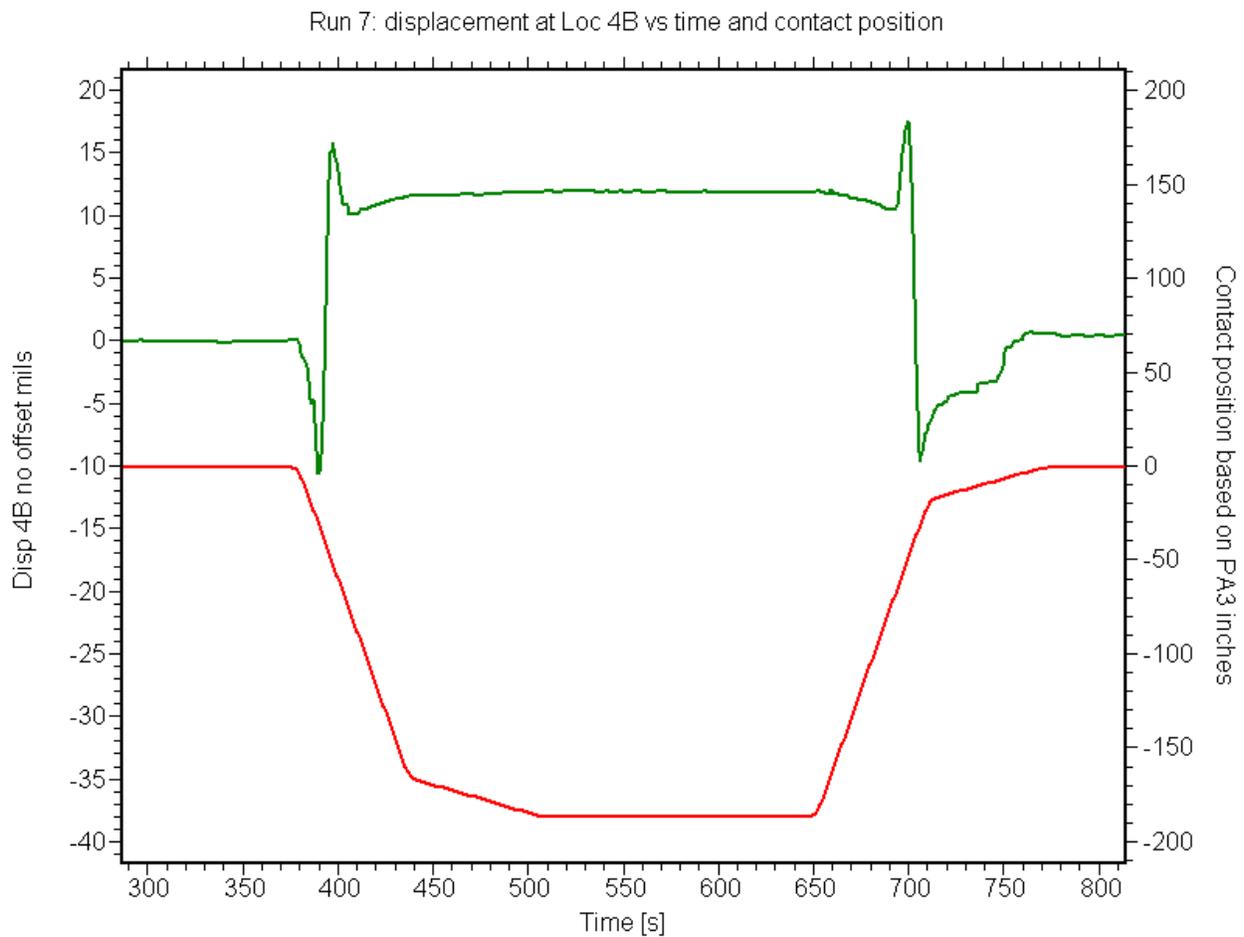
Figure 16: Superposition of parallel displacement at Location 4B ($x = -12$ in) and contact position during Run 7. Parallel displacement (green line) is given in mils. Contact position (red line, scale on right side of graph) is given in inches (arc length) along the rolling surface where $x = 0$ represents the contact position when the leaf is fully closed. This repeatable, quasi-static behavior, is typical of all the test runs on the west leaf, south bascule girder.

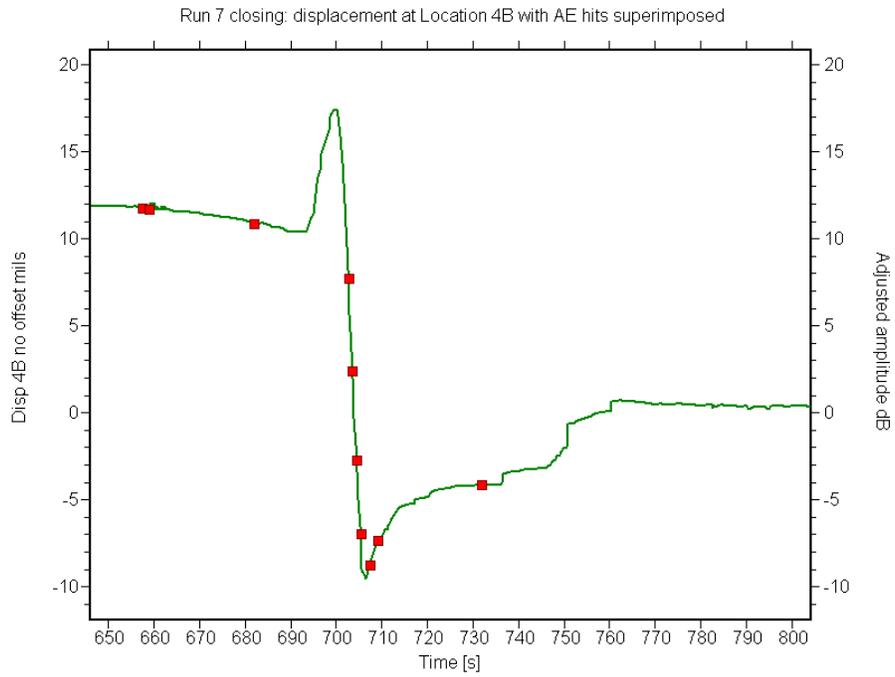
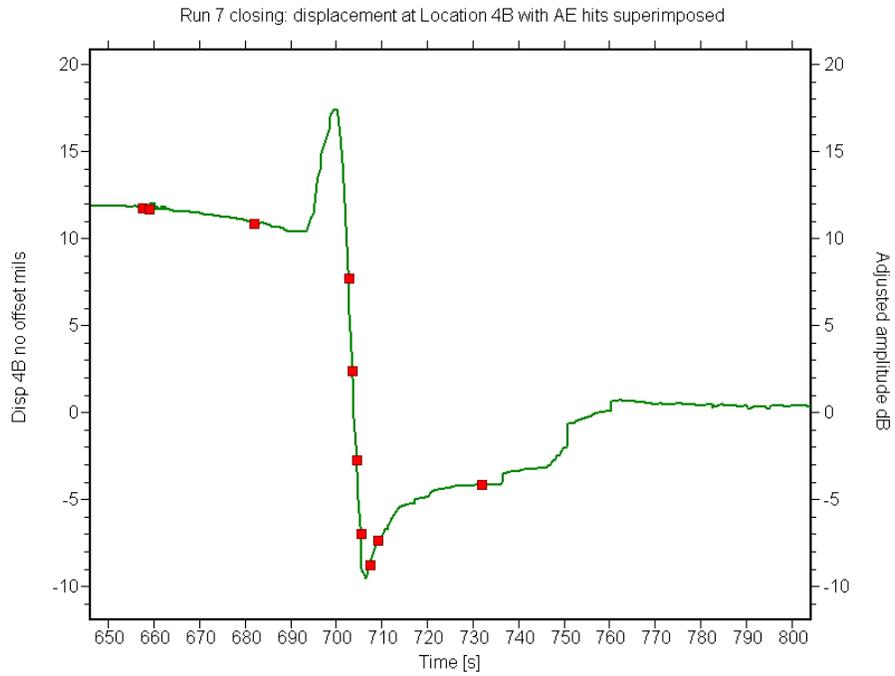
Displacements showed a rough correlation with AE events, as shown in Figures 17 and 18, wherein AE events can be seen near step-like jumps in the displacement record. This is consistent with stick-slip behavior between the bascule and curved forging being the source of the audible bangs. The red AE event points show that an event meeting out filter criteria occurred. The AE amplitudes themselves are meaningless, as they have been modified to follow the displacement plot for illustrative purposes.

Figure 17: Run 7 parallel displacement at Location 4B with AE events with energy greater than 600,000 AE energy units superimposed. AE amplitudes have been arbitrarily offset to generally follow the displacement plot for comparison purposes; the amplitudes displayed are meaningless.

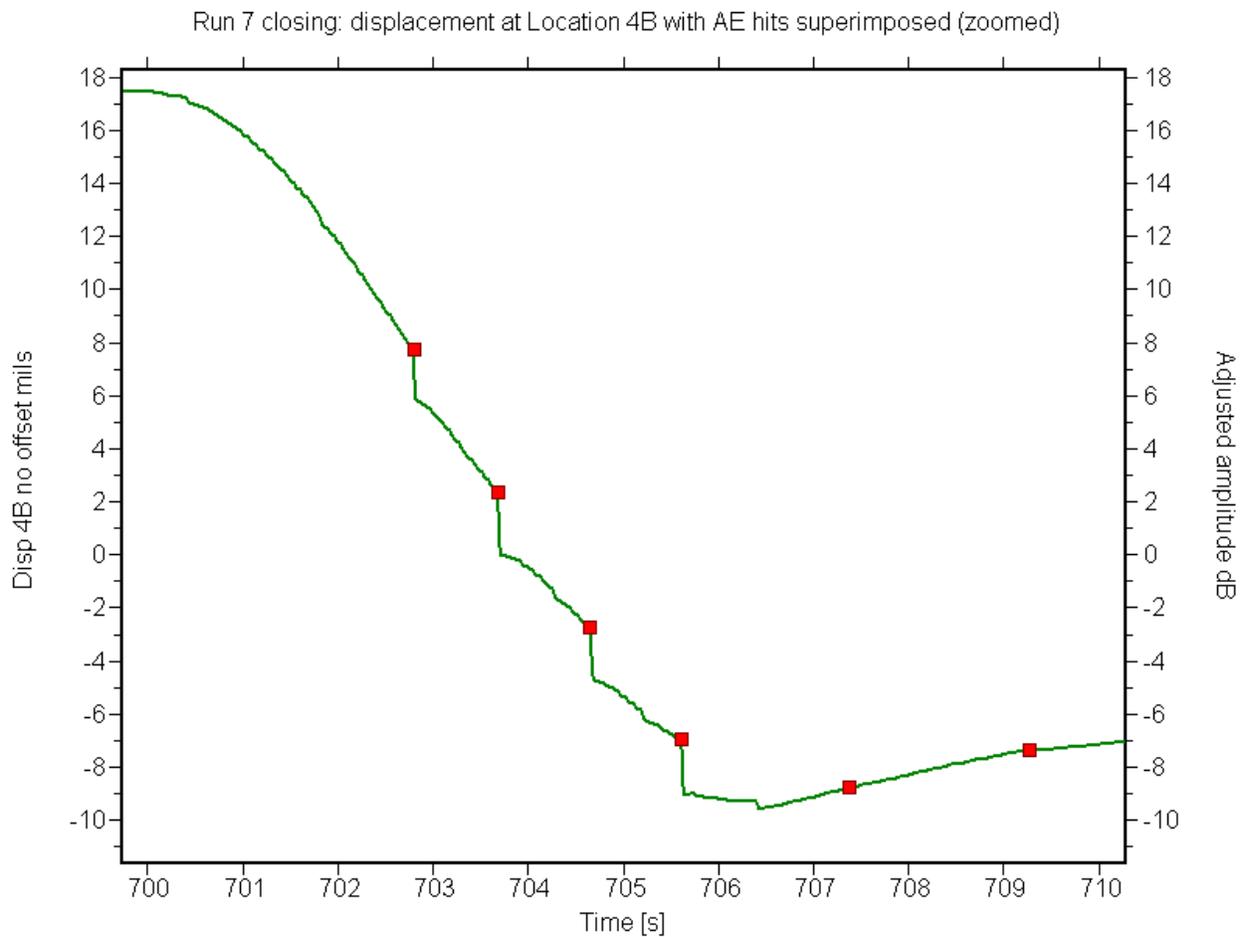
Figure 18: Close-up of Run 7 closing parallel displacement at Location 4B with AE events with energy greater than 600,000 AE energy units superimposed. As with Figure 17, the AE amplitudes have been arbitrarily offset and are meaningless. Note that each “jump” in the displacement data is accompanied by a high-energy AE event; this is typical of most of the events shown in Figure 17.
