**ACOUSTIC EMISSION AND STRAIN GAGE MONITORING  
OF PROTOTYPE RETROFIT FOR  
CALTRANS STRUCTURE B-22-26 R/L  
I-80 SACRAMENTO RIVER (BRYTE BEND)  
SACRAMENTO, CALIFORNIA**

**David W. Prine and Daniel Marron**

**Northwestern University  
Infrastructure Technology Institute  
1801 Maple Avenue  
Evanston, Illinois 60201**

**April 18, 1997**

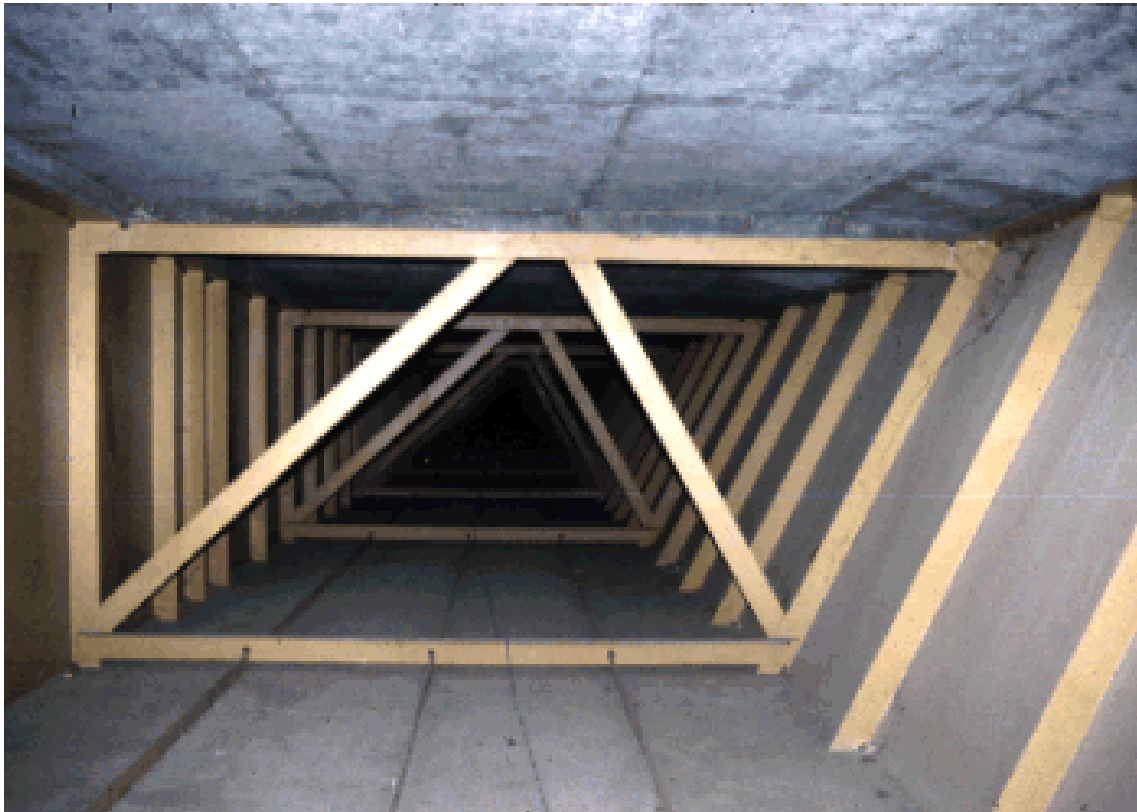
Figure 1. Typical Crossframe.

The Bryte Bend Bridge carries I-80 traffic over the Sacramento River near Sacramento, California. The bridge consists of two 4050-foot trapezoidal steel boxes, 36 feet wide. Its approaches are 146.5-foot simple spans 8.5 feet deep with main spans of 370 feet and 281.5 feet in length at a depth of 15.5 feet. Flanges on the sloped side and vertical center web support the composite concrete deck. In the early 1990s in-depth inspection by Caltrans personnel led to the discovery of cracks in the web of the trapezoidal box at the lower attachment point for the stiffener crossframes. A crossframe is shown in Figure 1. The cracks typically initiate around the toe of the weld that joins the vertical stiffener to the web. These sites are located at the bottom left and right corners of the crossframe as seen in Figure 1. Repeated observations showed that the cracks were growing and new ones were being initiated. In 1993, and again in 1994, researchers from Northwestern University's Infrastructure Technology Institute (ITI) used acoustic emission and strain gage monitoring techniques to provide additional confirmation of the active fatigue nature of the cracks.

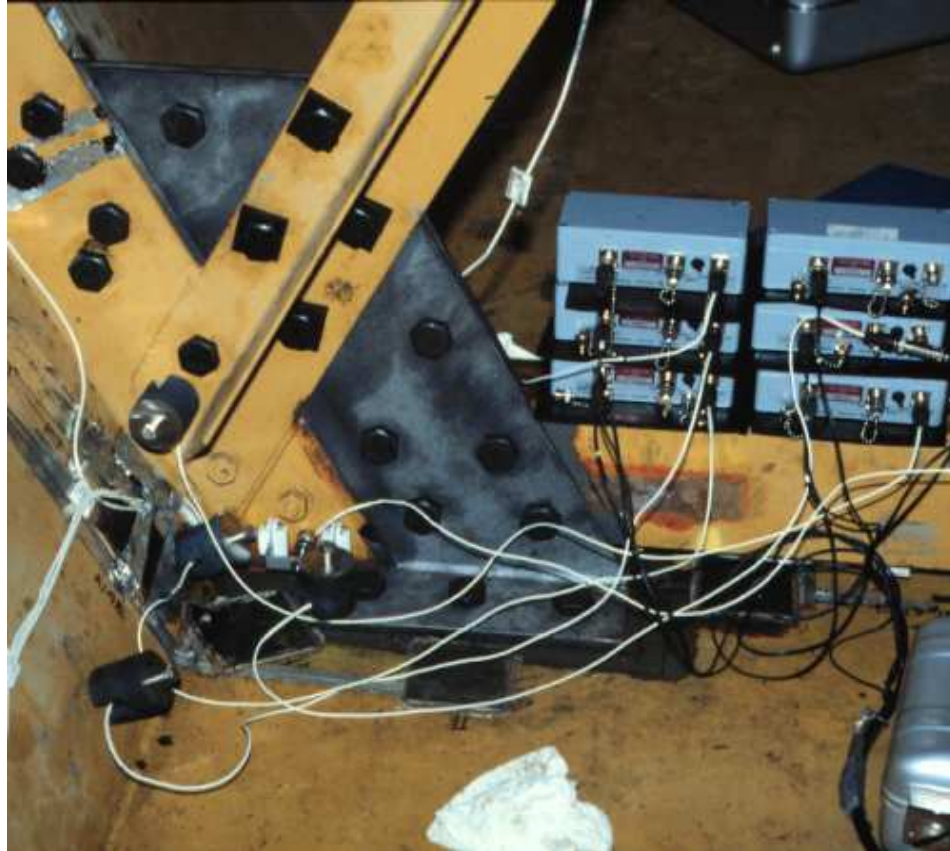
Figure 2. AE Setup.

Test Setup ITI engineers applied acoustic emission monitoring to six crack sites. The sites were located at the right, center and left corner of crossframes 3 and 4 in span 19L. Each of these sites had active fatigue cracks. Since this bridge is an all-welded structure (no extraneous acoustic noise sources were located adjacent to the crack), we were able to apply the acoustic emission using a simple multi-channel approach with first hit channel (FHC) analysis. This approach was developed and proven during previous AE testing on this structure by ITI. The FHC analysis evaluates the order of receipt of an AE signal at each of the sensors in the array. When the sensor mounted on the crack is the first hit channel, the signal had to originate at the crack. All other first hits are the result of extraneous noise sources. The array consisted of six sensors. A sensor was located at the visible crack tip and five others were placed in an array surrounding the crack tip. The six-channel approach is an improvement over the original (1993/1994) test setup that employed only four channels in that it provides additional immunity to non-crack related acoustic emission sources. A photograph of a typical AE test setup is shown in Figure 2. Dunegan Engineering Consultants Inc. type SE375 375 kHz sensors were used for the guards and a M9250 broadband sensor was used for the crack sensor. Preamplifiers with 37 dB gain were used to drive a 250-foot multi-conductor shielded coaxial cable that led from the test site on the bridge to a motor home parked under the bridge where the AE monitoring system was located. Figure 3 shows the motor home (loaned by Caltrans) and the lift bucket that was used for quick access to the testing area. Figure 4 shows the AMS3 and associated equipment set up inside the motor home. Unity gain line driving amplifiers were used to interface between the strain gage signal conditioner/data logger (Somat 2100 field computer) and the same 250-foot cable that carried the strain data to the AE monitor. The AE and strain data were recorded and analyzed with a digital AE monitor (model AMS3) manufactured by Vallen Systeme GmbH in Icking, Germany.

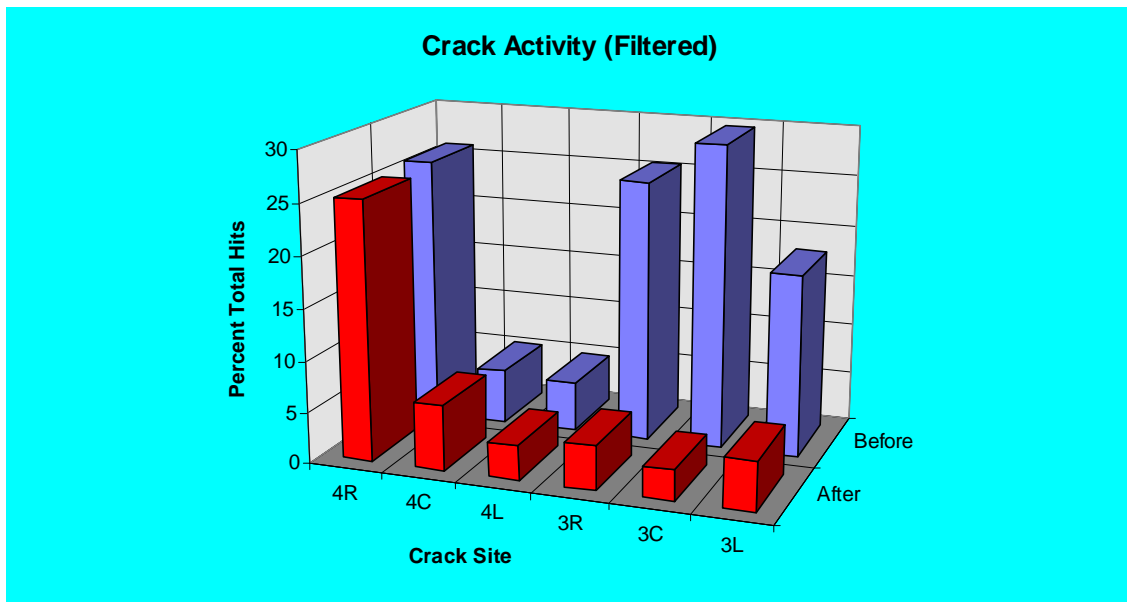
Figure 5. Plot of AE Results for Crossframes 3 and 4.

These results are shown in graphic form in Figure 5.

Crossframe 3 was modified by placement of plates or shoes and knee braces at the outside corners and both sides of the center web. Crossframe 4 had the same modification with the additional feature of disconnecting the diagonal braces from their attachment points at the deck and reattaching them to an added upper horizontal cross member. The crack-related AE activity was clearly reduced by the addition of the modifications in crossframe 3. However, in crossframe 4, which had the modified diagonal stiffeners, the effect on AE activity is not measurable. These results indicate that the frame 3 type modification results in a marked reduction in crack activity as measured by AE while the frame 4 type modification has no measurable effect on the AE results.

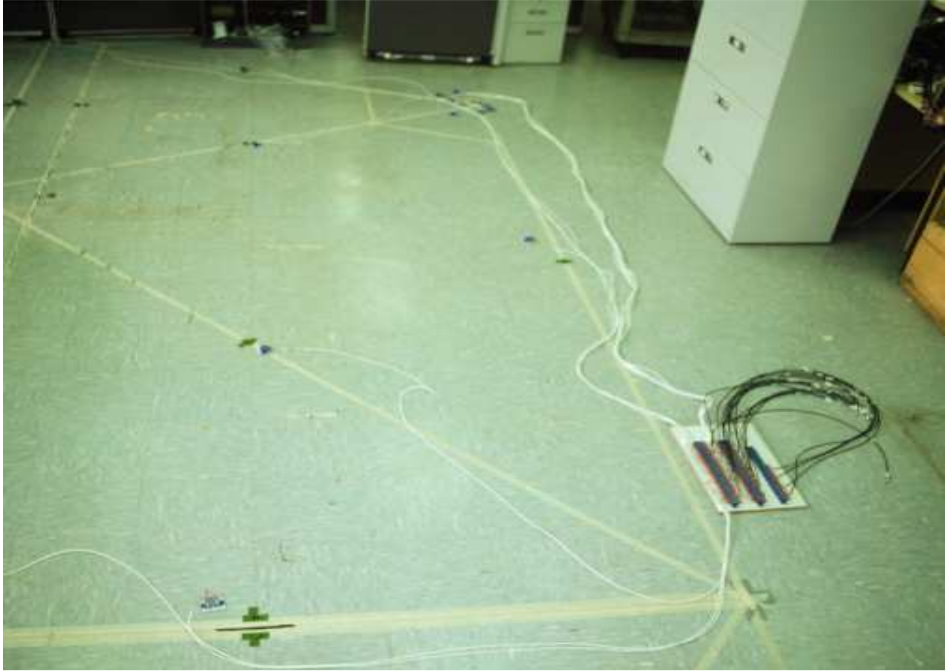
Figure 6. Crossframe Mock Up Used for Wiring Harness Development.

Installation Pre-wired resistive foil-type strain gages mounted on weldable steel shims were chosen for this application. The gages were 350 ohm, self-temperature compensated for mild steel, and had a gage factor of 2.2. All gages were supplied by J.P. Technologies of San Bernardino, California (part #WSG-06-1-350-V3C-25). These gages permit simple and rapid field installation by means of a portable spot welding unit (Measurements Group, Raleigh, NC, model 700). Gage installation consists of four steps: surface preparation, attachment, protection, and wiring. Caltrans removed paint and scale at gage sites by grit blasting. ITI engineers performed final surface preparation by manually abrading with 400-grit silicon carbide paper and degreasing. Gages were attached by spot welding the gage shim to the bridge using multiple 30 joule spot welds. Spot welding is a permanent installation method which, if properly protected, will not degrade over time like some adhesives. Protection was an especially important consideration for this application because the gages also had to survive the retrofit process. A multi-layer system was chosen. Each gage was first covered with an adhesive Teflon patch to provide corrosion protection and a release surface so the other protective layers could be removed for inspection without damaging the gage. This was then followed by a thick layer of Dow Corning 732 RTV silicone, a 1/8-inch-thick neoprene rubber pad, and adhesive-backed aluminum tape. The gage's unique number was then written in permanent ink adjacent to the protected gage. The bulk of the wiring task was completed before installation began. Based on drawings and photographs, ITI engineers laid out a full-scale mock up of a crossframe in the lab. A photograph of the mock up is shown in Figure 6.

An individual screw terminal strip was labeled and placed at each gage location on the mock up. A board of labeled screw terminal strips was placed at the central instrumentation location. Shielded instrumentation leads were then labeled and run along the mock up, avoiding retrofit
