Blast Induced Micrometer Response of Cracks in Concrete Block Structures

Charles H Dowding,
Professor of Civil and Environmental Engineering, Northwestern University

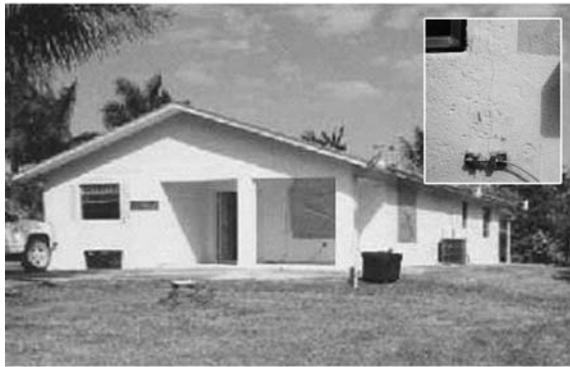
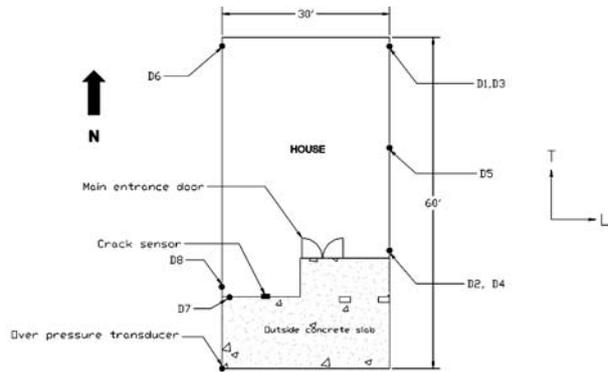
The concrete masonry unit (CMU) house shown in the top left in Figure 1 was located on mine property and thus could be subjected to ground motions far greater than with non owned structures. Its response was monitored with a hybrid autonomous crack monitoring system (ACM), as well as two multi channel vibration monitoring systems, both of which were constructed by GeoSonics. Like the hybrid described in the 2001 surface coal mining studies (Aimone-Martin et al , 2003) this combination recorded vibratory time histories of crack & structure response, ground motions and air over pressures as well as long term, climatological crack response.

This single story ranch house was constructed with external concrete CMU walls and was founded on a concrete slab as are almost all homes in southern Florida. The external CMU walls were covered with a coat of stucco to produce a uniform surface. Internal walls, ceiling joists and roof trusses were constructed of wood. Internal walls were covered with gypsum drywall. Locations of the transducers are shown in the plan view of the house on the top right in Figure 1. An external crack in the stucco over CMU below the south facing window shown in the inset in the house photograph was monitored with a Kaman eddy current micro meter displacement sensor. Velocity transducers 2 and 4 were attached perpendicularly (low and high respectively) to the N-S wall in the SE corner of the structure, as shown in the house plan in Figure 1 (top right). Thus super structure motions are measured in a direction parallel to the wall containing the crack.

Figure 1. Photographs (left) and crack locations (right) of block structures from (beginning at the top) Miami Florida; Ft Lauderdale, FL; Gilfach Iago, Wales, UK, and Franklin, WI.

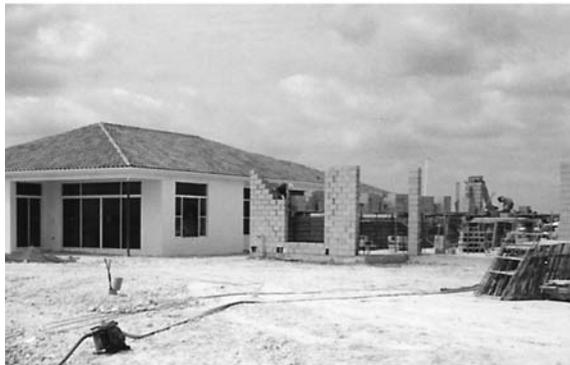
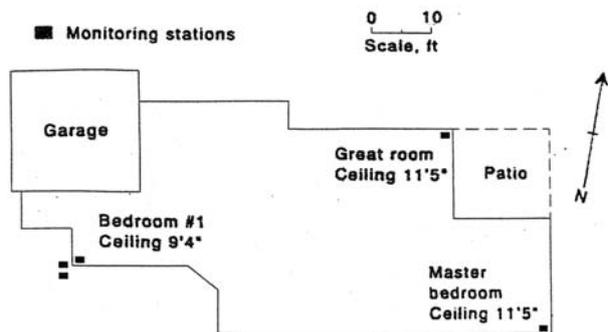
The single story structure in the photograph second from the top in Figure 1 was constructed with external CMU walls, and was founded on a concrete slab like that in Miami. Details of the block construction can be seen on the right side of the same photograph at the house under construction adjacent to the instrumented house. Critical corners of the outer walls are constructed of cast-in-place reinforced columns and a continuous reinforced concrete beam is poured on top of the outer walls. Interior walls, ceiling joists and roof framing are constructed of wood or equivalent steel “C” steel members. The exterior walls and surfaces are covered with stucco to produce a uniform surface.

Kaman crack sensors were placed across an interior, taped dry wall joint on the north wall and on the exterior patio ceiling across an exterior stucco crack between two metal mesh sheets on which the stucco was applied. Geometry and sensor (monitor) locations for this structure are shown in the plan to the right of the photograph in Figure 1. Taped drywall joints are interfaces between adjacent sheets of drywall that are spanned only by paper tape covered with a 1 to 2 mm thick plaster coat to smooth the interface. Field measurements verify that the joints are more responsive than wall materials (Dowding, 1996). Velocity transducers were placed at the upper and lower corners of the NE and SW corners to measure relative displacement of the walls.

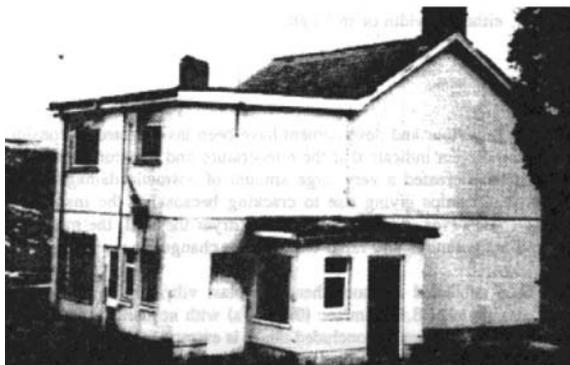
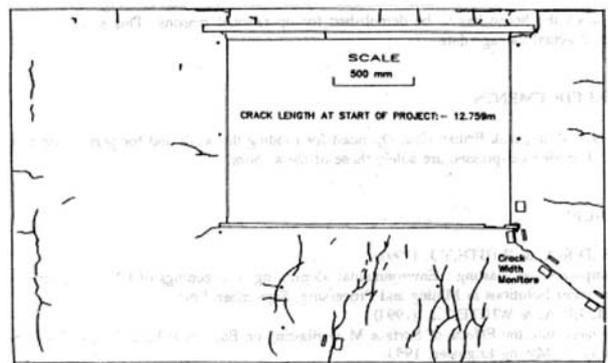
The two-story house second from the bottom in Figure 1 was fitted with LVDTs and a continuous blast monitoring system (White, Farnfield and Kelly 1993) to record ground motions and structural response generated by near-by surface coal mine blasting. Vibration and LVDT responses were measured separately and thus the system differs from an Autonomous Crack Monitoring system; however the LVDT measurement of crack response can be employed for comparison with the other case studies to assess possible similarities and differences.

Cracks were fitted with LVDTs in two rooms in the newer rear extension of the elderly stone cottage because of the poor condition of the original portion. The extension was a “double skin concrete block construction with external rendering and internal plaster” (White et al, 1993). Internal walls were constructed of “plaster board”. External walls were founded upon a trench filled with concrete and brick. Lack of a structural connection between the two portions exacerbated differential movement and resulted in a large, external active crack between the extension and original structure.

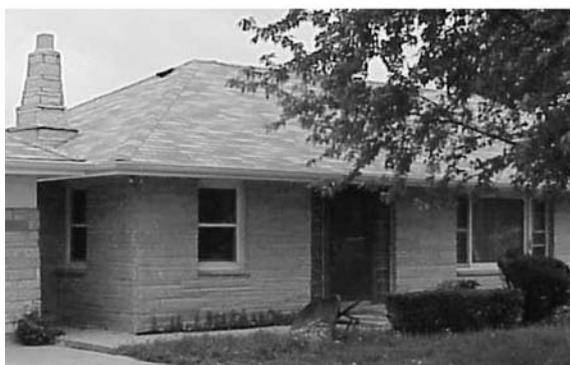
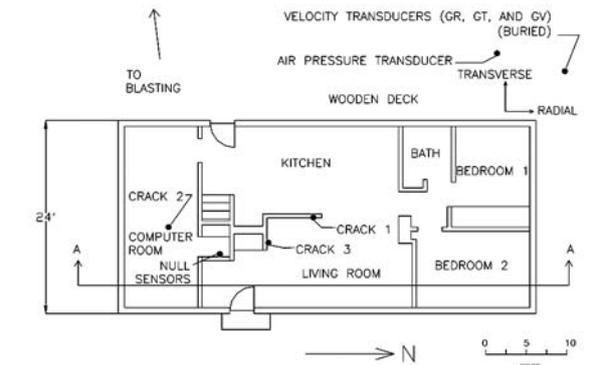
As shown in the photograph at the bottom of Figure 1, this ranch style house's exterior load bearing walls are constructed of stone cemented to a concrete masonry load bearing wall. Interior walls are constructed with typical wood framing. The interior surfaces of the exterior walls are covered with gypsum drywall. A full CMU basement, with a walkout entrance, serves as the foundation.

Kaman crack sensors have been placed across the three cracks located in the plan view on the bottom of the right hand side of Figure 1. Cracks 1 and 3 were located at the corners of openings between rooms, with that between the living room and kitchen (beneath crack 1) some 3 doors wide. The ceiling crack, 2, is in the center of the study where a ranch style house's typical center wall support would be located.

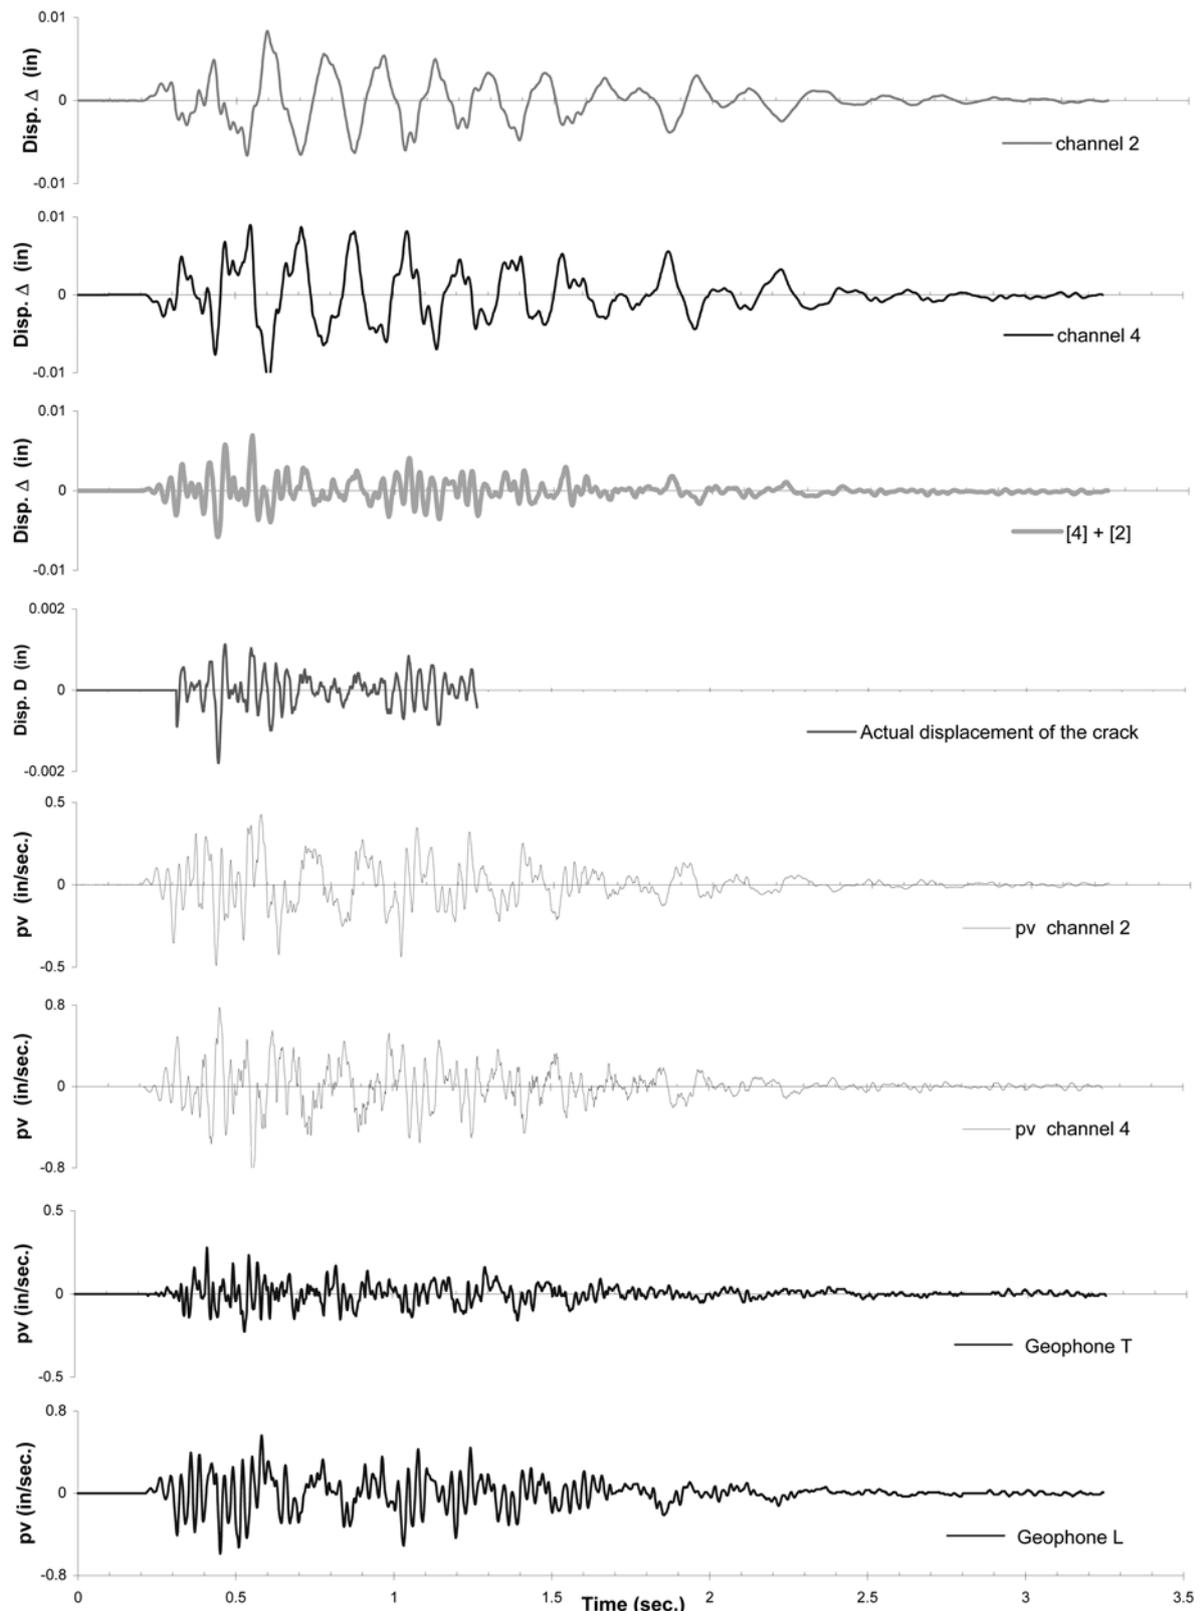
Crack and wall motions in the plane of (parallel to) the wall containing the crack for the 16 December event are shown in Figure 2. Measured crack response, the 4th time history from the top of the figure correlates well in terms of frequency content with the calculated relative displacement between the top (channel 4; D4) and bottom (channel 2; D2) shown in the time history third from the top.

Figure 2. Time histories produced by 17.8 mm/s (0.7 ips) Miami FL blast (from top to bottom) A) structural displacement response (2 & 4) and their difference (4+2) compared to crack response (actual...); B) structural velocity response (pv ch. 2 & 4) compared to ground motions (Geophone T & L).

Dynamic structural response properties in Table 1 were obtained from free vibration response like that at the ends of response time histories like that in Figures 2 and 6. Estimates of natural frequency and damping from time history data (some of which is presented here) in Table 1 show that the single story Florida structures have natural frequencies (7 – 10 Hz) that bracket that for the Welch structure. Since one would expect the natural frequency of a 2-story structure to be less than that of a single story structure, this might imply that the Welch 2 story structure is slightly stiffer than a typical US structure. However, it appears that responses of the Welch structure were of the walls and not the super structure. Therefore more response motions at the corners of European block structures are needed. Similar calculations can be made to determine damping constants, which are 5 and 6% for that Floridian and Welch structures respectively. Thus they have similar damping constants.

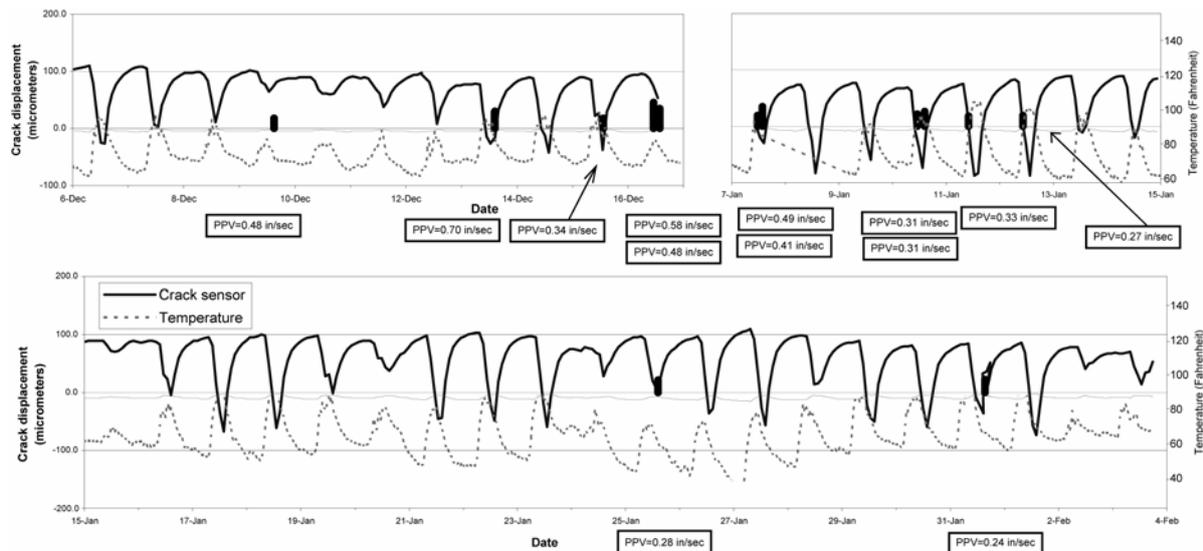
Figure 3. Comparison of vibratory crack responses (solid vertical bars) with cyclic long term responses (solid line) shows that even motions exceeding regulatory limits cannot produce crack responses as large as those produced by temperature change. Comparison of long term response with temperature variation (dotted line) shows the high correlation with temperature change.

Climatologically induced crack response from mid November to early February in Figure 3 shows the heavy influence of the direct solar heating on the south facing wall. This graph compares blast-induced crack response (solid vertical bars) with the long term time history of climatologically induced crack response (thin solid line). The long term crack response pattern can be compared with the variation of external temperature (dotted line) as well as the response of the null sensor (vanishingly thin solid line). The null sensor is another Kaman sensor placed across an adjacent, uncracked section of the south wall to measure sensor and wall material response. Despite the high degree of solar heating (compare temperature and crack response), the null sensor response was small. Comparison of the time history of the crack response with that of the temperature in Figure 3 shows less crack response on days with more constant temperatures, which is most likely a result of cloudiness and lower temperature induced strains from direct sun exposure (insolation) on the south facing wall containing the crack.

Close-by quarry blasting produced ground motions with peak particle velocities (PPV) as high as 17.8 mm/s (0.7 ips) in the direction parallel to the wall containing the crack as shown by the PPV values in the boxes in Figure 3. Peak crack responses to these events are shown as bars, which extend upward from the 0.0 crack displacement line, whose height is proportional to the 0 to peak crack response. This comparison shows that even motions that are 140% of the frequency independent control limit of 12.7 mm/s were unable to produce crack responses greater than 0.61 (61%) of those induced by typical daily temperature changes.

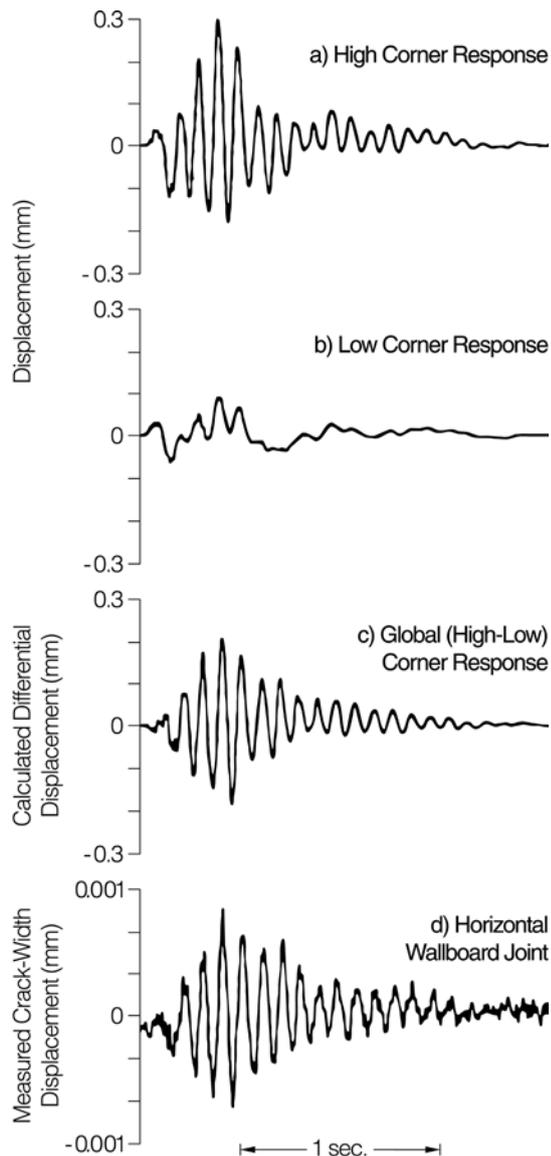
Figure 4. Time histories produced by 11 mm/s (0.43 ips) Ft Lauderdale blast (from top to bottom like that in Figure 2): structural displacement response (upper -a- and lower -b- corner) and their difference (c, high minus low) compared to the response of dry wall joint (d - bottom).

Structural response time histories from the shot producing the highest PPV's, 11 mm/s (0.43 ips), are compared to the time history of the taped horizontal dry wall joint in Figure 4. Response of the horizontal wallboard joint (bottom of figure) on the north wall is compared with the north-south "displacement" responses at the high and low corners (top of figure) as well as the relative displacement between bottom and velocity transducers. This differential displacement produces a relative displacement time history that matches that of the drywall joint.

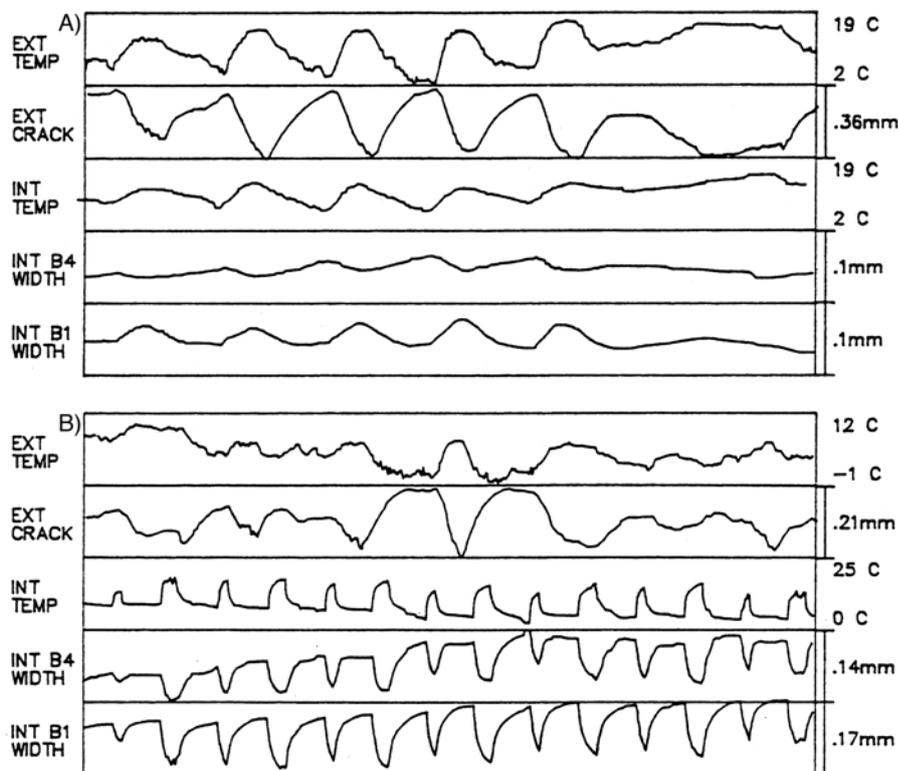
Typical long term crack responses are compared for a week with external and internal room temperatures in Figure 5a and b with and without active room heaters respectively. Response of three cracks is compared: one external crack and two internal. The external crack was that between the old and new portions. Internal crack B 1 is on an external block wall and internal crack B4 is on an internal “plasterboard” wall. Wall B 1 is shown in on the right hand side of Figure 1 (second from the bottom), with its cracked condition along with the location of the crack monitors. The crack at the corner of the window extended into the concrete block. There is no description of the frame for the internal wall, which is likely to be wood given the presence of plasterboard, and is assumed to be similar to gypsum dry wall in the US.

Interior heating affects interior cracks on both plasterboard interior and block exterior walls. Without heaters response of the external crack between the addition and original structure was absolutely large and larger than that of the internal cracks showing a daily peak to peak response of 0.36 mm or 360 μm (14,400 $\mu\text{in.}$) The cracks within the addition responded far less and more typically: 27 and 45 μm for the plasterboard and block walls respectively. Operation of the heaters twice per day changed the periodicity of responses of the internal cracks to match the heater activity but not that for the crack between the new and old portions. In addition the larger temperature swings induced larger responses of the cracks inside the addition. The large daily swings of the crack response between the two sections of the structure are probably the result of numerous differences in the structures; foundation depth, materials, framing, etc.

Figure 5. One week's worth of long term change in width of 3 cracks compared with temperature for the Wales house similar to that shown in Figure 3 for the Miami, FL house. Response with no internal heat at the top and that with internal heat twice a day at bottom. Crack B1 is in an external block wall (White et al, 1993).

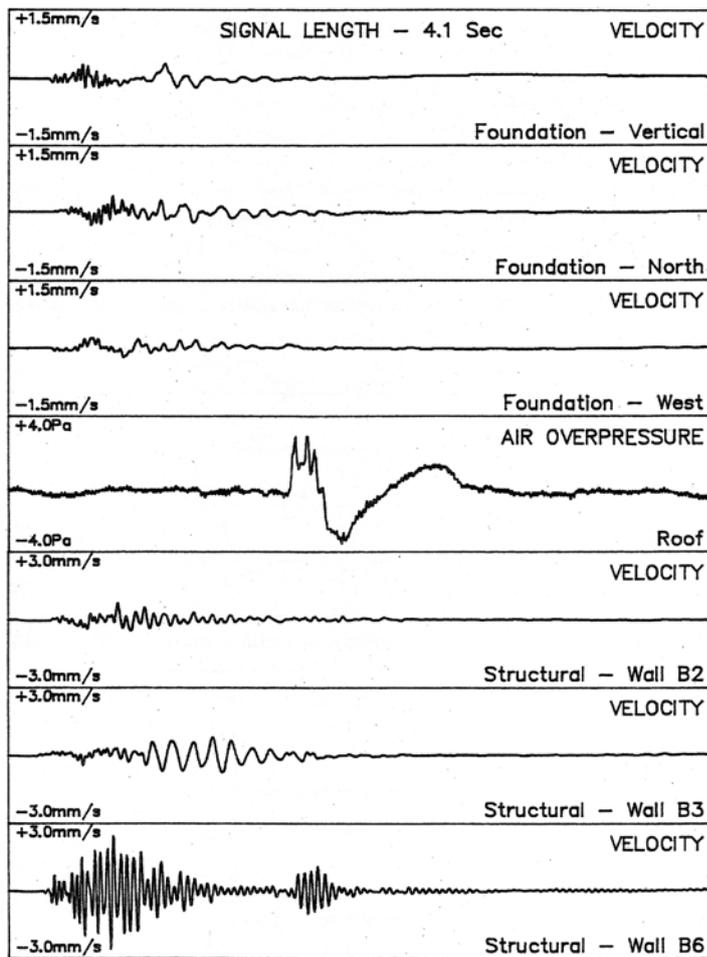
Figure 6. Comparison of typical low level velocity excitation and wall response time histories reveal a variety of wall responses (from White et al, 1993).

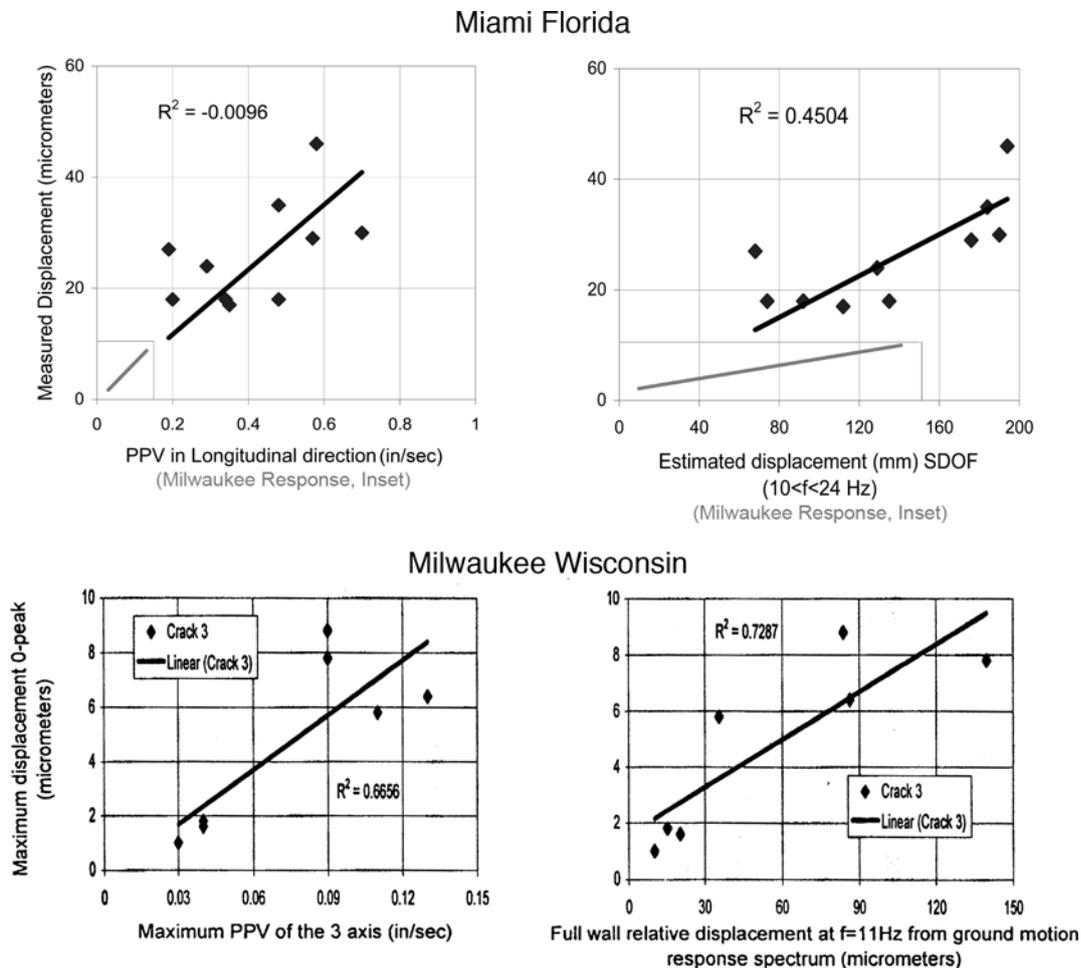
Crack response is compared to peak particle velocity in the direction of the wall containing the crack in Figure 7 to for the Milwaukee and Miami cases. As can be seen, the Milwaukee case involved typical ground motions near quarries (0.8 to 3.3 mm/s). On the other hand the Miami case involved unusually high PPV's 17.5 mm/s because it was owned by the quarry and was located on their property. There exists a rough correlation between PPV and crack response (left graphs), but since excitation frequency and time history (number of pulses, exact timing, etc) are not included in the PPV magnitude, the correlation coefficient (R) can be low. In this case correlation can be improved

through comparison of crack response with the single degree of freedom response spectrum of the ground motions as shown in the right hand graphs (Dowding and McKenna, 2005). The smaller Milwaukee excitation and responses are included in the Miami graphs in the insets at the lower left of both Miami graphs.

Figure 7. Comparison of crack response with peak particle velocity PPV (on left) and single degree of freedom response SDOF (on right) for the Miami case (top) and the Milwaukee case (bottom) shows rough proportionality with PPV but a higher correlation with SDOF response because of the inclusion of excitation frequency. (PPV in ips where 1 ips = 25.4 mm/s)
