## **Real Time Monitoring of Subsidence Along I-70 in Washington, Pennsylvania**

Abstract. Two longwall coalmine panels were mined at a depth of approximately 156 m (510 ft) beneath I-70 east of Washington, Pennsylvania such that it crossed the width of one panel at two locations. The Pennsylvania Department of Transportation (PennDoT) assumed responsibility for real time monitoring of both ground deformation and changes in highway conditions.

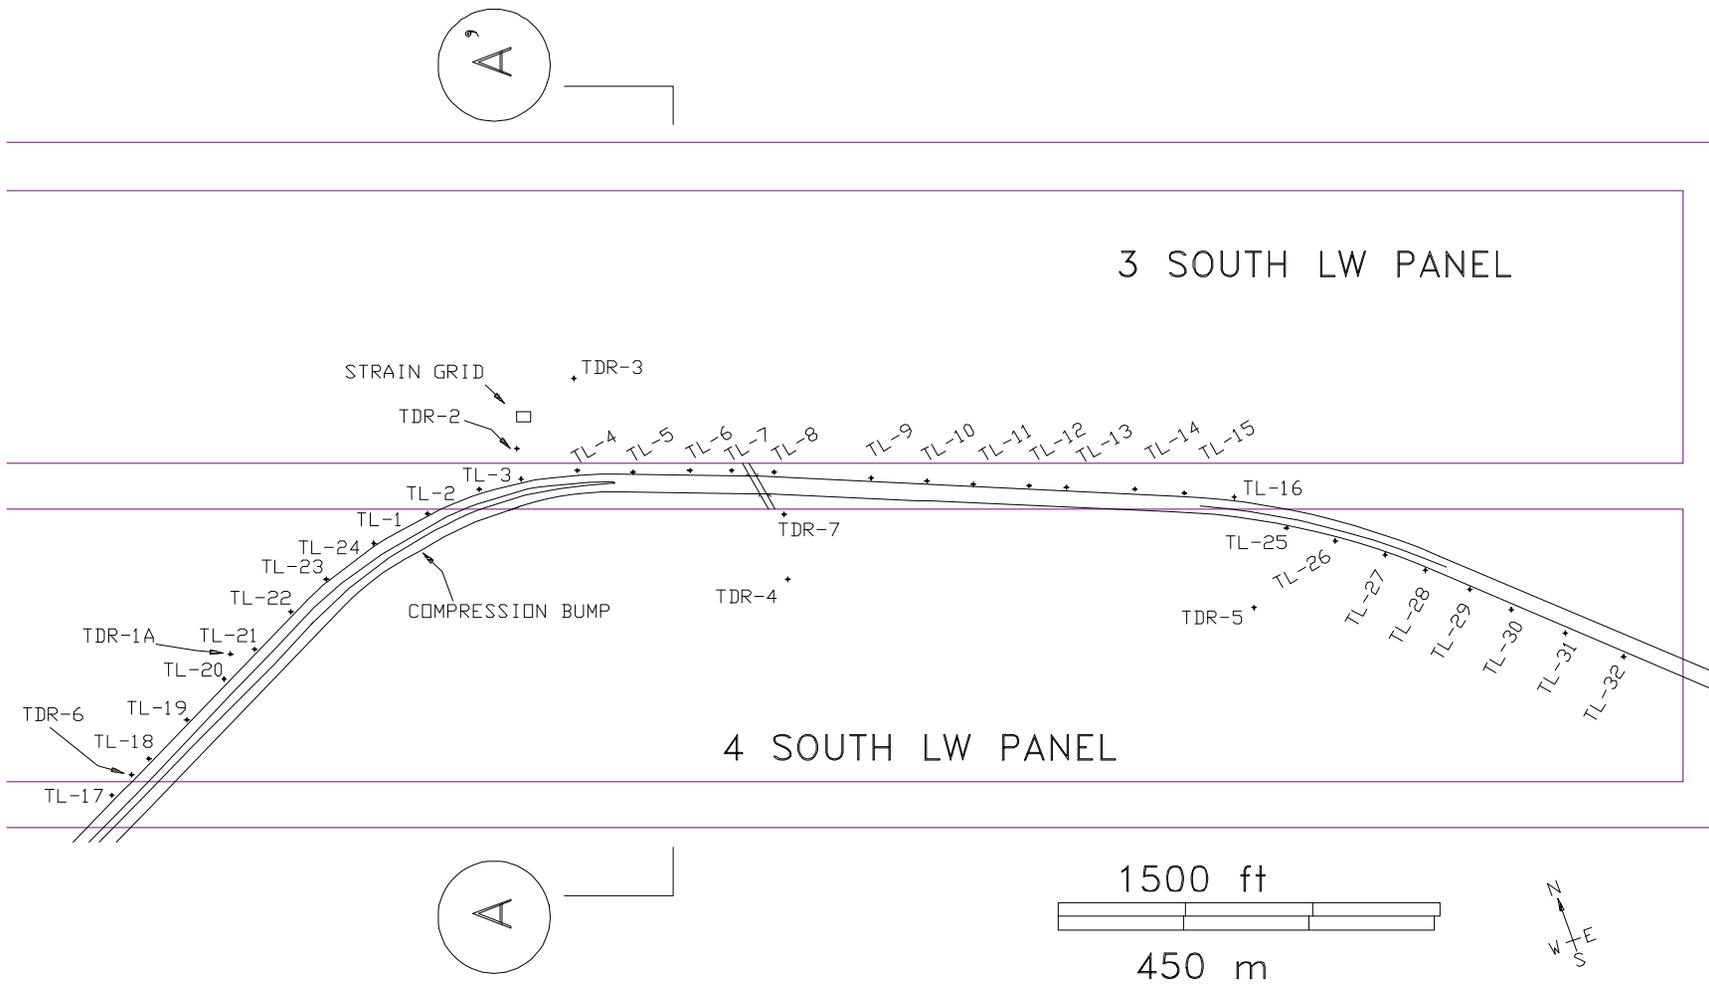
**Figure 1. Plan of highway, instrumentation, and longwall mine.**

of moveable roof supports to excavate an entire block of coal 332 m (1090 ft) wide and 2650 m (8700 ft) long as shown in Figure 1. A shearer moves across the full width of a panel making a cut about 1 m (3 ft) deep and loads the coal onto a conveyor that transports it to another loading point. Hydraulic roof supports are advanced behind the shearer and the mine roof and overlying rock fracture and collapse into the void behind the supports. Caving and fracturing propagate up through the overlying rock mass as shown in Figure 3.

Precursor subsurface deformation was monitored by grouting coaxial cables shown in Figure 4 into holes drilled from the surface to within 46 m (150 ft) of the coal seam as shown in Figures 1 and 3. The cables were interrogated with Time Domain Reflectometry (TDR) (3). It was originally planned to install cables at seven locations where the highway intersects the edges of the mine panels, but four holes (TDR1, TDR3, TDR4, and TDR5) were moved closer to the centerlines of the panels to increase sensitivity to precursor movement ahead of the advancing mine face.

Biaxial tiltmeters shown in Figure 5 were installed along the roadway shoulder at a spacing of 60 m (200 ft) beginning at the location where it intersects Panel 4 South as shown in

Figure 1. The tiltmeters (Applied Geomechanics Little Dipper) have a resolution of 0.006 arc-degree and a range of +/-10 arc-degrees. Detachable fins allow the tiltmeters to be installed in slotted inclinometer casing that is grouted into a 150 mm diameter auger hole. The x-axis was oriented perpendicular to the longwall panel centerline (N30E) and the y-axis was oriented parallel to the centerline (N60W).

The northern panel (3 South) was mined between November 22, 1999 and March 1, 2000 and averaged 30 m (100 ft) of advance per day. Panel 4 South was mined between March 3, 2000 and October 4, 2000 and averaged 15 m/day (50 ft/day). The roadway was only marginally impacted as Panel 3 South was mined since chain pillars along the south edge of this longwall panel support the road as shown in Figure 1. However, the roadway crosses over the centerline

A 12-mm-high compression bump developed in the highway at a location 44 m from the north edge of Panel 4 South as shown in Figures 1 and 10. This location corresponds with the maximum final strain as indicated by the profile in Figure 3 and summary in Table 3. The bump occurred 19 days after this location had been undermined.

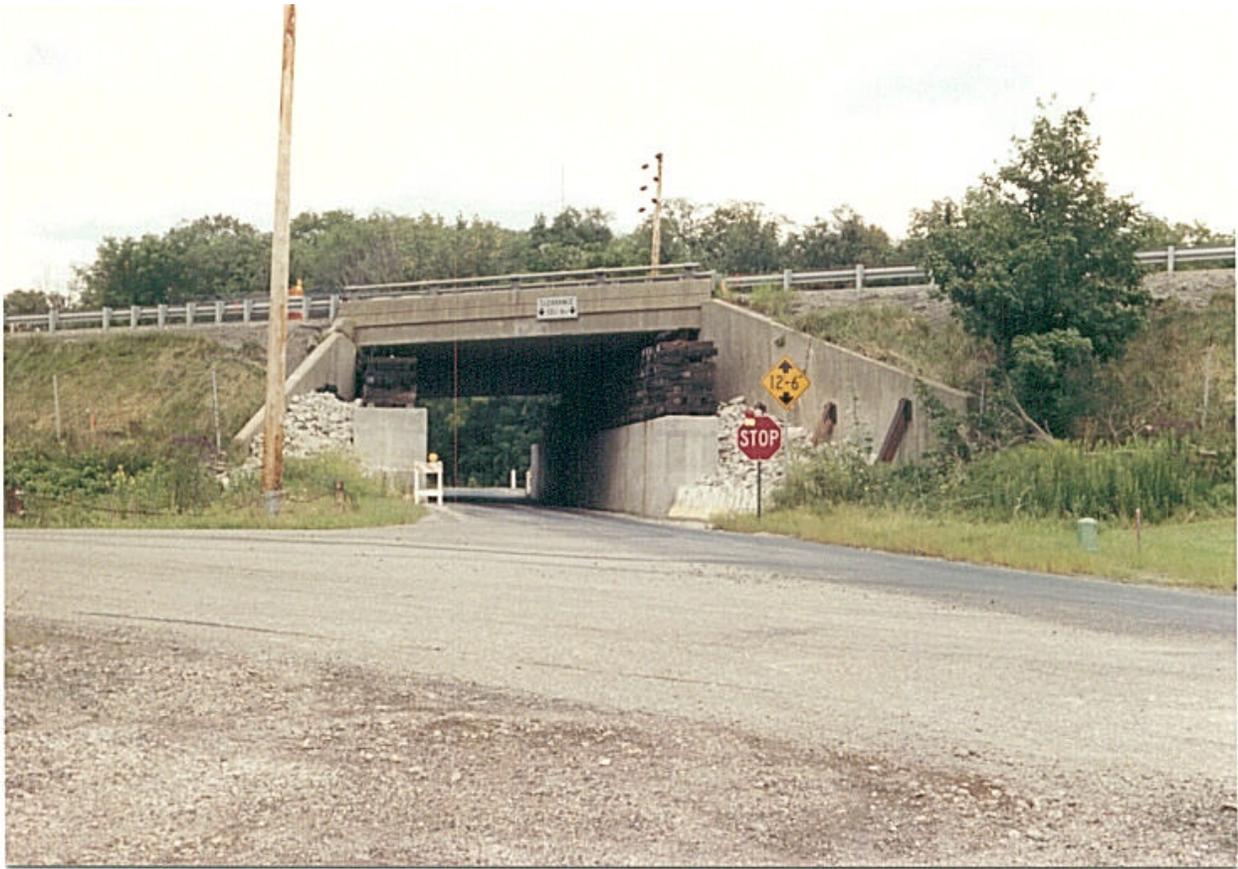
**Figure 2. View looking northeast at Zedeker Road overpass. The cast-in-place reinforced concrete blocks and wood cribbing were placed to provide additional support for the bridge deck. TDR-7 is located at the enclosure on the right side of the road.**

When it became apparent that the section of I-70 shown in Figure 1 was going to be undermined using high extraction techniques, PennDoT recognized the likelihood of damage occurring to the pavement and to structures that could shut down the highway. The integrity of the overpass shown in Figure 2 was already questionable, past experience had taught PennDoT that the pavement would subside and crack, and there was concern about tilt affecting the hydraulic performance of reinforced concrete box culverts underlying the highway. While it would be possible to make repairs after mining was completed, the immediate need was to ensure the safety of the driving public as the highway was undermined.

The plan of action developed by PennDoT was multifaceted with the primary objective being protection of the driving public. Proactive components of the plan included increased support for the single-span overpass shown in Figure 2, dismantling of overhead sign structures, installation of an alarm system, and visual monitoring. Reactive components of the plan included reducing the speed limit to 57 km/h (40 mph), lane closures, and provisions to detour traffic in case closure of all lanes was deemed necessary. The alarm system consisted of an array of tiltmeters along the highway (at locations shown in Figure 1) connected to a central data acquisition system for automated monitoring. Complementing the tiltmeters were more than one

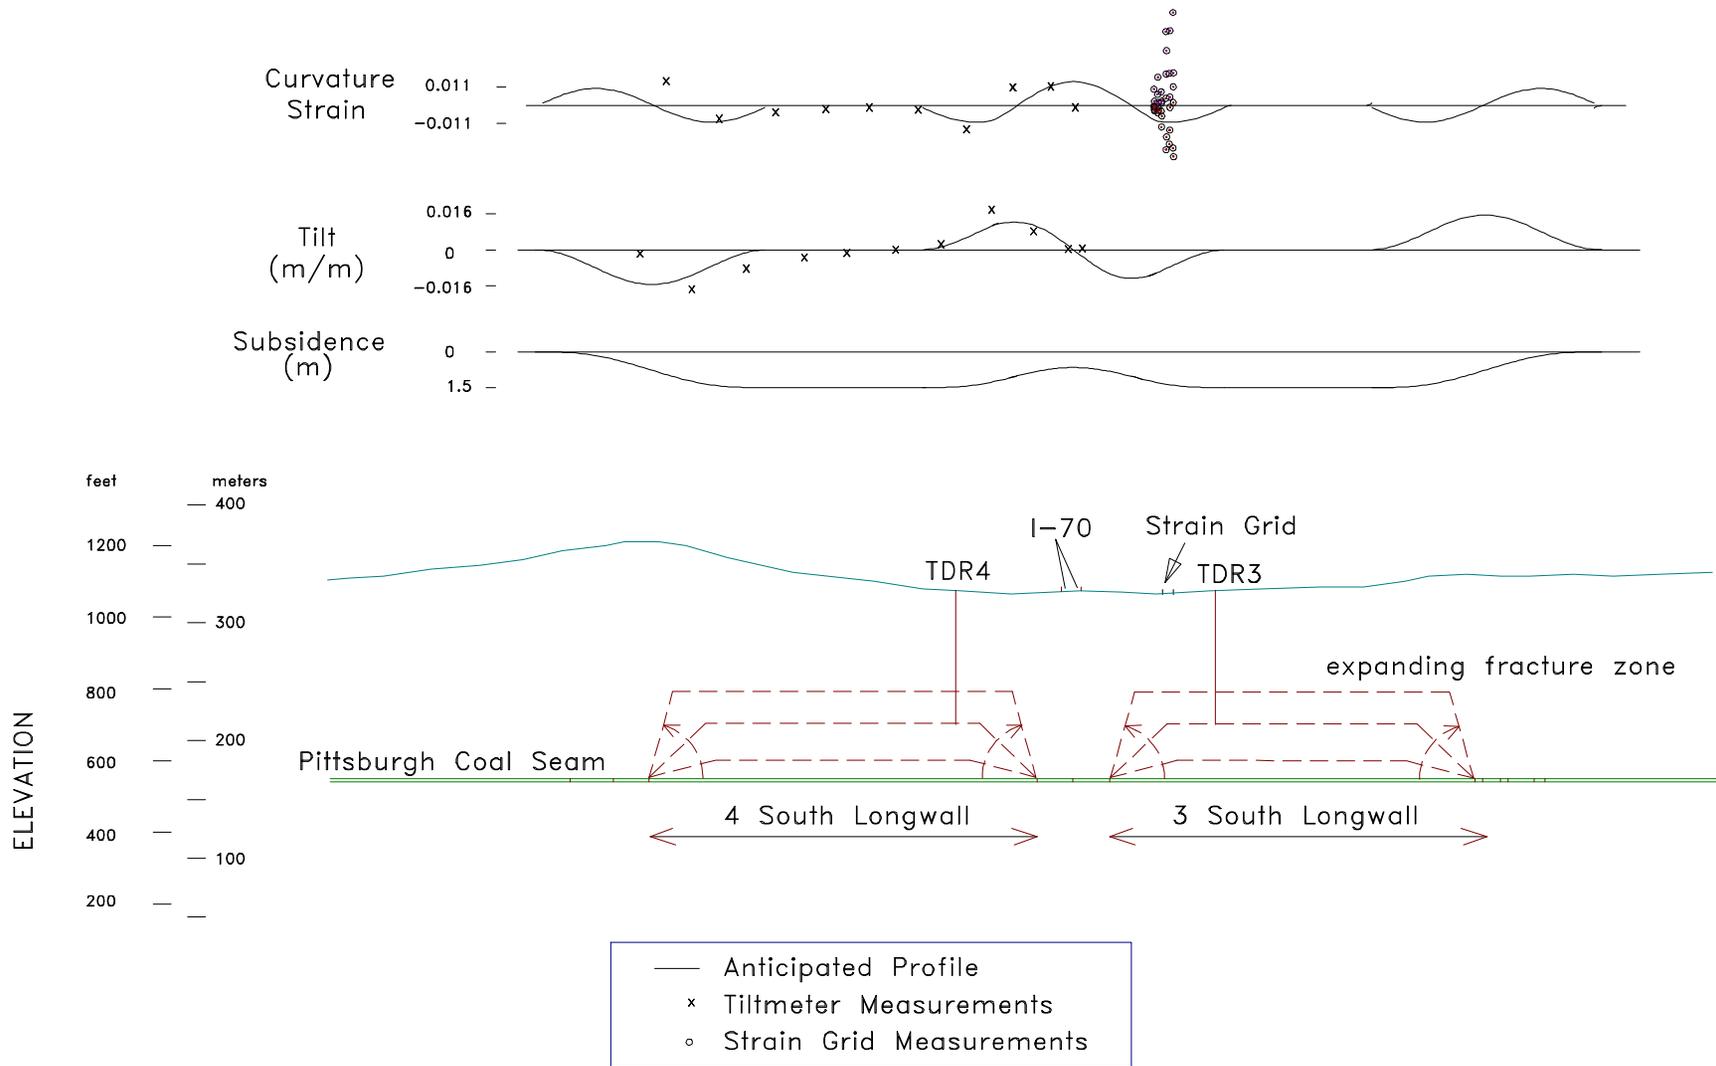
**Figure 3. Subsidence, tilt and curvature strain profiles along transverse cross section AA'. See Figure 1 for location. The solid lines are anticipated profiles and the dots are measured values. The fracture zone ultimately reached an equilibrium configuration**

The 1.8 m (6 ft) thick Pittsburgh coal seam shown in Figure 3 was being mined 156 m (510 ft) below the highway by the longwall mining method. This mining technique involves use

With this loss of support, subsidence of the overlying rock mass is a certainty and the ground surface ultimately deforms into a trough with maximum subsidence of 1.0 to 1.5 m (3 to 5 ft) as shown by the transverse profile in Figure 3. Around the margins of this trough, differential vertical movement of the surface causes tilt, and curvature is caused by differential tilt. This curvature causes tensile and compressive strains. Slope and curvature of the surface impacts the line of sight of drivers. Curvature-induced strains cause both general and, occasionally abrupt, deformation of pavement and structures.

The instrumentation was installed to provide a real time monitoring system and to provide quantitative information about ground response to supplement PennDoT's experience and database of visual observations and survey measurements. The locations, precision and range requirements for instrumentation were determined on the basis of the mine layout shown in Figure 1 and the anticipated subsidence profile (2) shown in Figure 3.

While the primary purpose of the tilt measurements was to provide an automated monitoring and alarm system, the difference in slope between adjacent tiltmeters can be used to estimate curvature. The slope of the ground surface is a vector that changed in magnitude and direction as mining progressed and subsidence occurred, so the tiltmeters were oriented to measure slope components parallel and transverse to the longwall centerline. Measurements obtained along the highway from tiltmeters TL-17 to TL-3 (see Figure 1 for location) are summarized in Table 1 and the measured final transverse components are plotted in Figure 3 for comparison with the anticipated final transverse slope profile.

As a consequence of differential tilt, the ground surface, pavement and structures were subjected to curvature. Humping curvature caused tensile strain while sagging curvature caused compressive strain. The anticipated final transverse strain profile is shown in Figure 3 with tensile strain being positive and compressive strain being negative. Superimposed on the profile are measurements from the strain grid and values computed from the differential tilt between adjacent tiltmeters. These computed values are also summarized in Table 2 to show that the largest final strains occurred near the margins of the subsidence trough where there was the greatest difference in tilt.

It is more pertinent to consider the curvature and strain actually experienced by the highway. By resolving the tilt measurements into components parallel to the road centerline it is possible to estimate the maximum difference in slope between adjacent tiltmeters that occurred as the steep subsidence profile moved along with the mine face. These computed peak strains are summarized in Table 2. They did not occur simultaneously along the road but sequentially over the period from 5/5/00 to 5/15/00. Note that the transient peak strains, even over the center of the longwall panel, were as large as the final strains along margins of the subsidence trough. Furthermore, these strains should be considered average values since it is likely that localized strains as great as 0.04 may have occurred based on the maximum strain grid measurements shown in Figure 3.

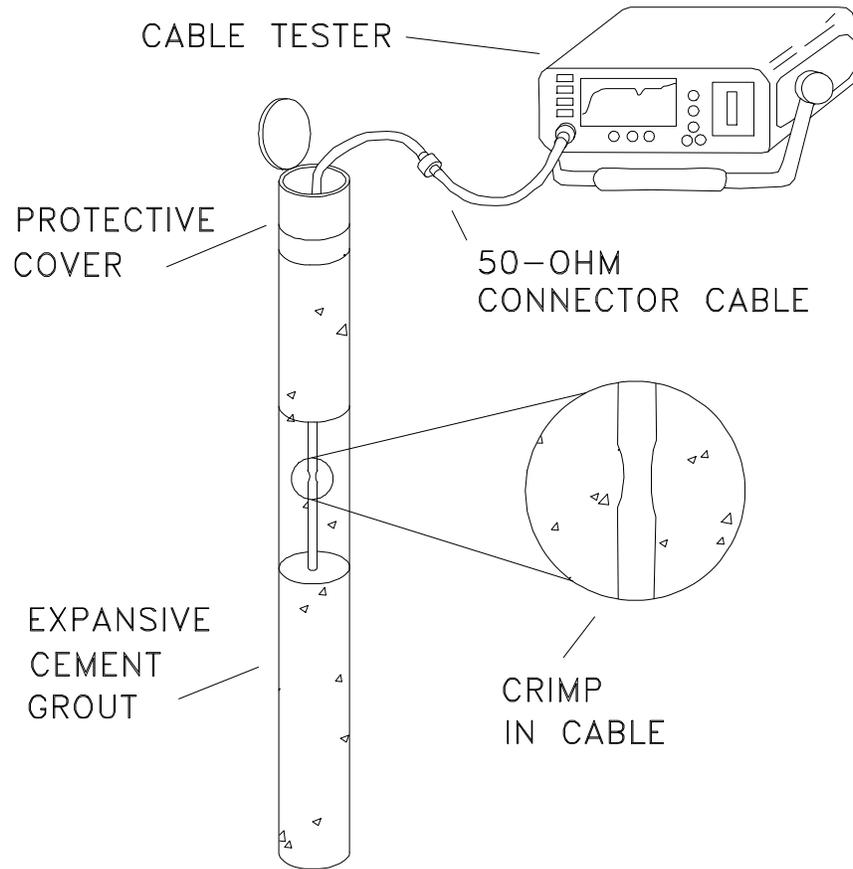
**Figure 4. Schematic of coaxial cable installation, and interrogation with a TDR cable tester.**

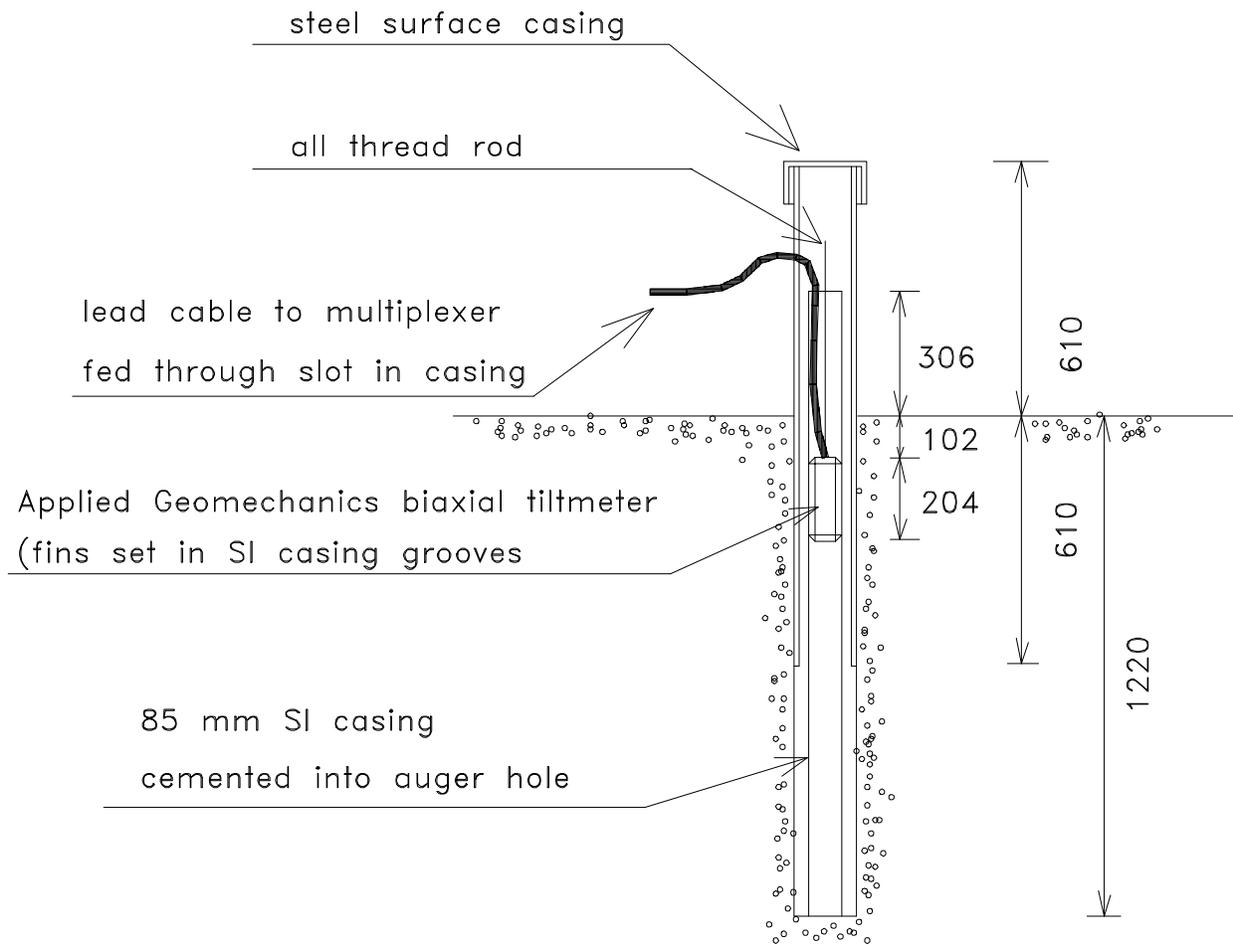
**Figure 5. Tiltmeter installation details with dimensions shown in millimeters.**

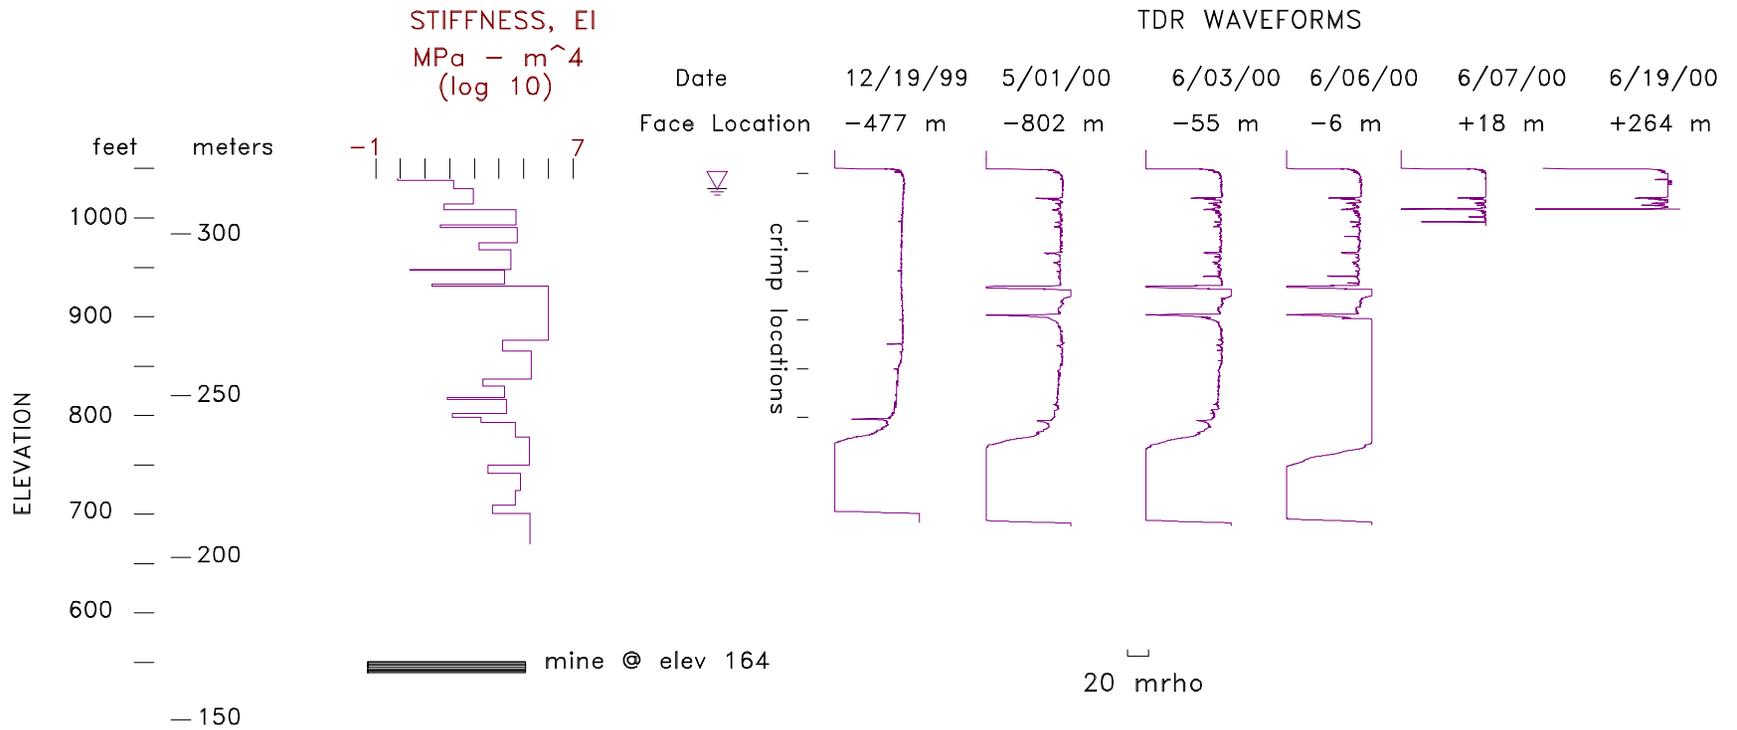
**Figure 6. TDR waveforms acquired at location TDR4. The TDR reflection spikes indicate where cable deformation occurred due to rock mass movement. They occurred at depths where there are stiffness discontinuities in the rock mass.**

As the longwall face advanced, there was a continual redistribution of shear stresses with the surrounding rock mass, and movements occurred along discontinuities such as bedding planes that caused deformation of the coaxial cable. The spikes in the TDR signatures shown in Figure 6 developed at each location where the cable was being deformed. This deformation was concentrated at depths where there were large changes in strata stiffness (10) represented by the histogram on the left side of the figure. This behavior was evident in all the TDR cables. In spite of the fact that distances of 30 m to 1200 m separate the cables, deformations were concentrated at specific discontinuities in specific strata.

Precursor movement occurred ahead of the mine face and outside the edges of the panel being mined. For example, the TDR signature for 6/3/00 in Figure 6 shows that precursor movement was detected when the mine face was over 55 m from the cable. However, the waveform for 5/1/00 shows that movement had occurred even earlier due to mining of the previous mine panel (Panel 3 South) that was over 135 m north of the cable location. Typically, cables detected precursor movement 200 m from active mining but one cable detected movement as far as 365 m from active mining.

TDR reflection spikes such as those show in Figure 6 increased in magnitude as shearing deformation increased and the magnitude of the spike was converted to magnitude of deformation (3) as summarized in Figure 7. Precursor shear deformation was detected when the face was more than 200 m from the cable and the rate of deformation increased when the face was within 60 m (200 ft) of the cable.

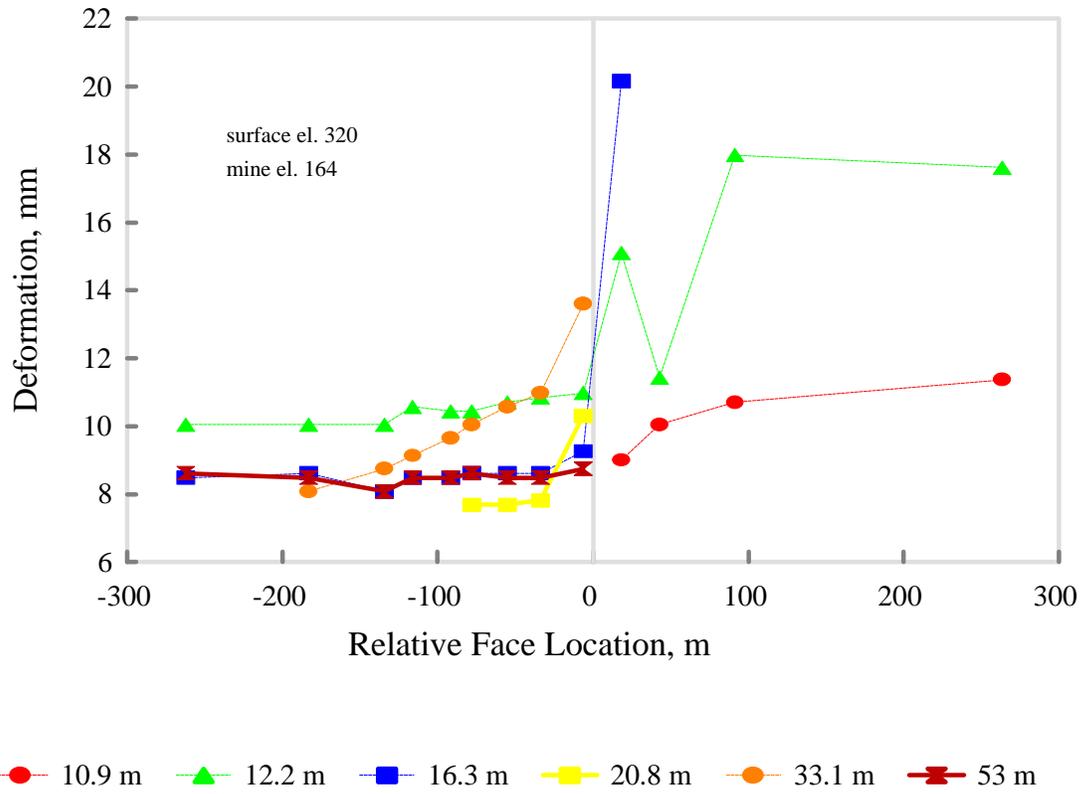
**Figure 7. Time history of shear deformation in cable TDR4 at depths of 10.9 m, 12.2 m, 16.3 m, 20.8 m, 33.1 m, and 53 m.**

TDR provided more sensitivity to precursor movement. A comparison of Figures 7 and 8 shows that the rate of subsurface movement increased when the face was within 60 m of a cable, but the tiltmeters did not detect surface movement until the mine face was directly beneath the tiltmeter.

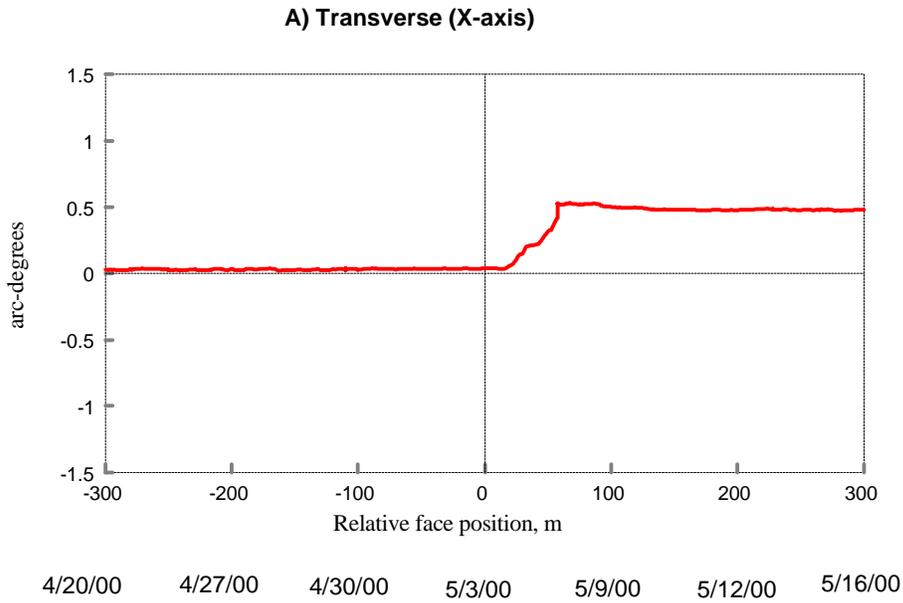
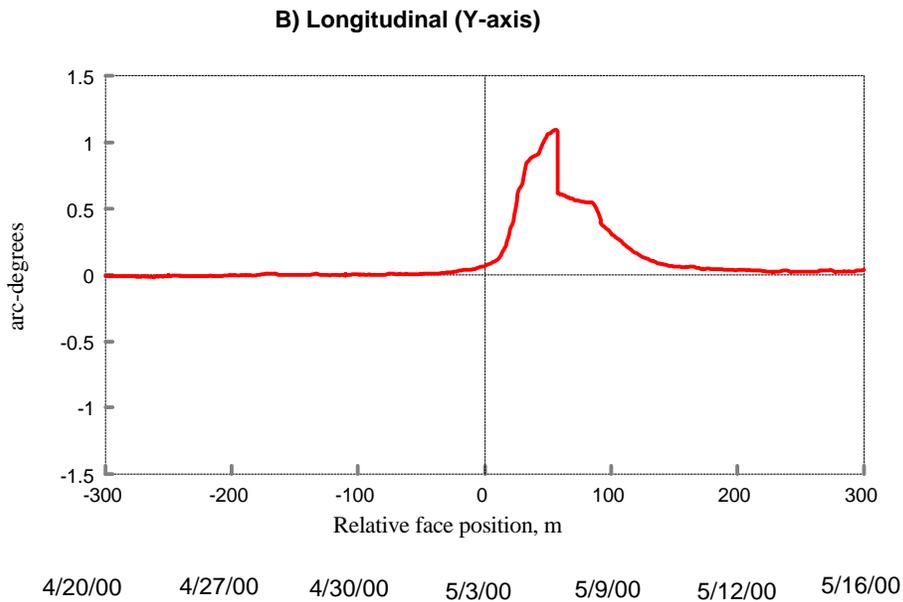
**Figure 8. History of tilt at location TL19 as the mine face advanced underneath this location; A, x-axis is transverse to the panel centerline and in the plane of Figure 3; B, y-axis is parallel to the panel longitudinal centerline and shows the steeper transient slope moving with the mine face.**

In a longitudinal cross section, the subsidence profile over the advancing mine face is transient and has a steeper slope than the final profile shown in Figure 3. As shown by the y-axis time history in Figure 8, tilting began as the face moved underneath a location, reached a peak value, and then decreased to a final value close to 0.0 arc-degree after the face was well past the location as the rock mass approached equilibrium. The peak and final longitudinal tilt measurements across the longwall panel are summarized in Table 1 to illustrate the much greater transient tilt and curvature experienced by the highway as it was undermined compared to the final equilibrium profile in Figure 3.

Peak strains over the panel centerline were transient as demonstrated by the longitudinal time history in Figure 8b. However, final strains along the margins of the subsidence trough were permanent. This difference was reflected in the highway's response to subsidence.

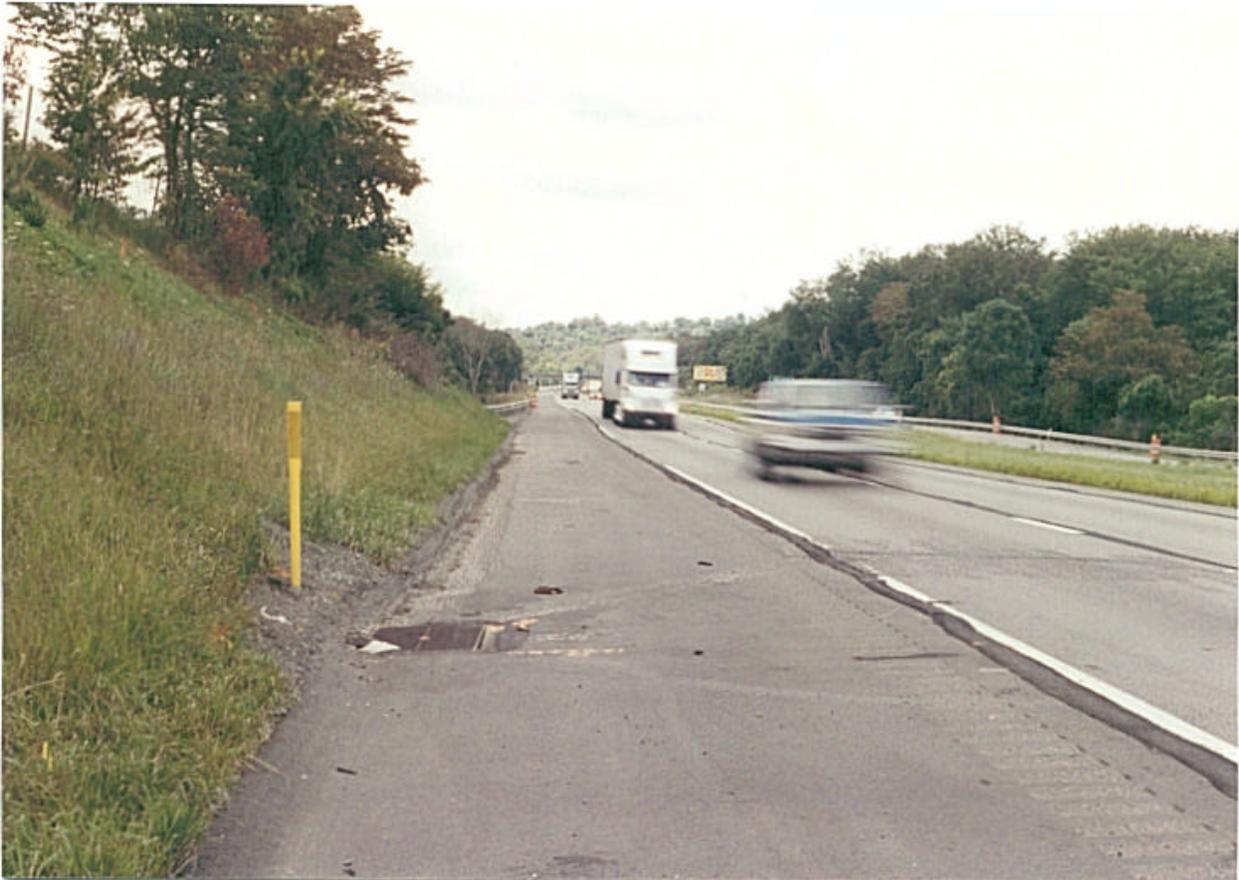
**Figure 9. Margin of final subsidence trough over the south edge of Panel 4 South. Note the guardrail in the right of the picture.**

The tilt and curvature caused by subsidence are apparent in the pavement dip and guardrail sag along the southern edge of Panel 4 South as shown in Figure 9. During periods of reduced visibility (night, fog, rain, snow, etc.) it would not be apparent to drivers that there is such a dip in the road. This was one reason that PennDoT reduced the speed limit to 67 km/h (40 mph) over the section of I-70 shown in Figure 1.

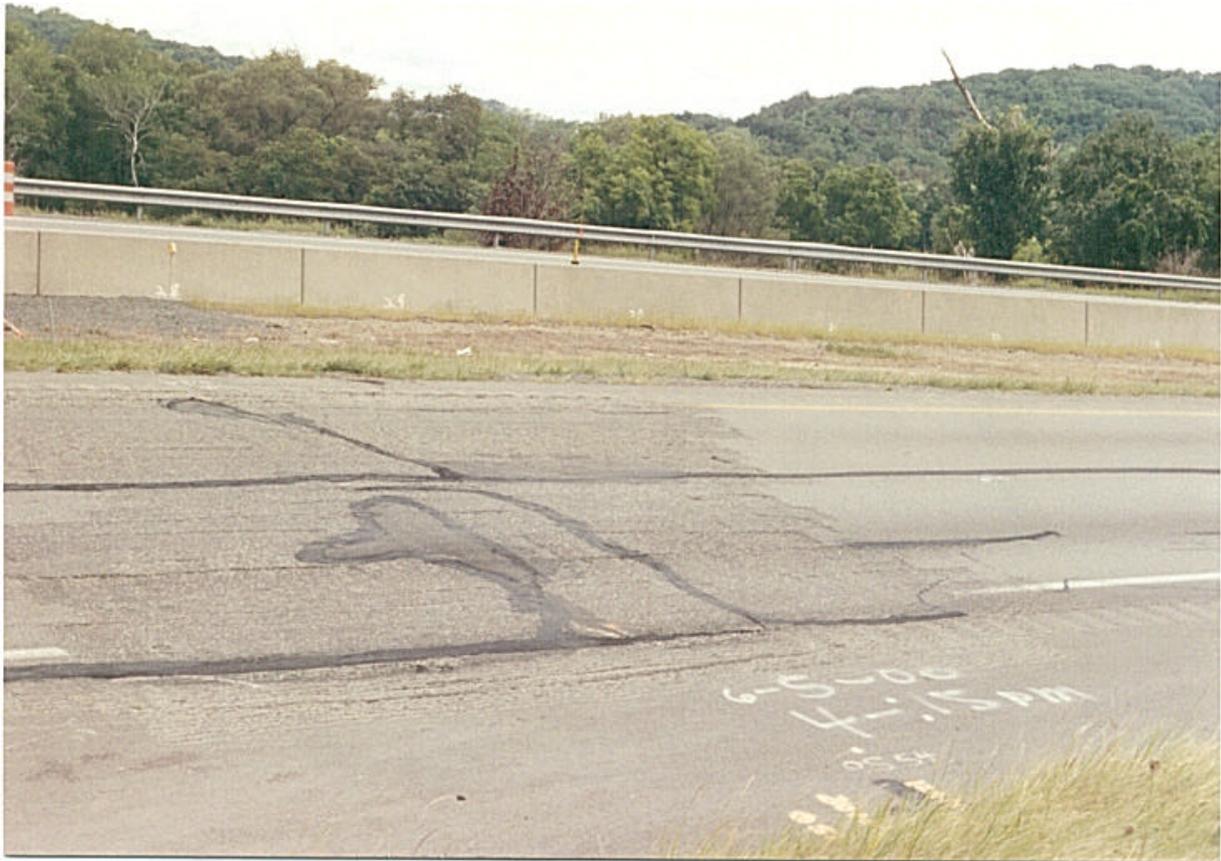
**Figure 10. View looking northwest at the location where the 12 mm high compression bump developed. The asphalt was ground down to relevel the road surface.**

After this bump occurred, PennDoT restricted traffic during the morning rush hour to one lane in each direction. Traffic was backed up while the hump was milled smooth then all four lanes of the highway were opened at 1:30 pm. The state police, the Department of Environmental Protection and PennDoT continued to reduce the speed limit in the area to 67 km/h (40 mph), monitor the highway 24 hours/day, and make repairs as needed.
